The usage of pavement drains in roads with asphaltic revetment - The Brazilian experience road BR-277

SCIAMMARELLA, J. C.

**TECHNICAL CO-RESPONSIBLE FOR THE RESTORATION PROJECT OF THE ROAD BR-277
PAVEMENT – SECTION CURITIBA - PARANAGUÁ**

**RESPONSIBLE FOR THE SUB-SUPERFICIAL DRAINING PROJECT OF THE BR-277 – SECTION
CURITIBA - PARANAGUÁ**

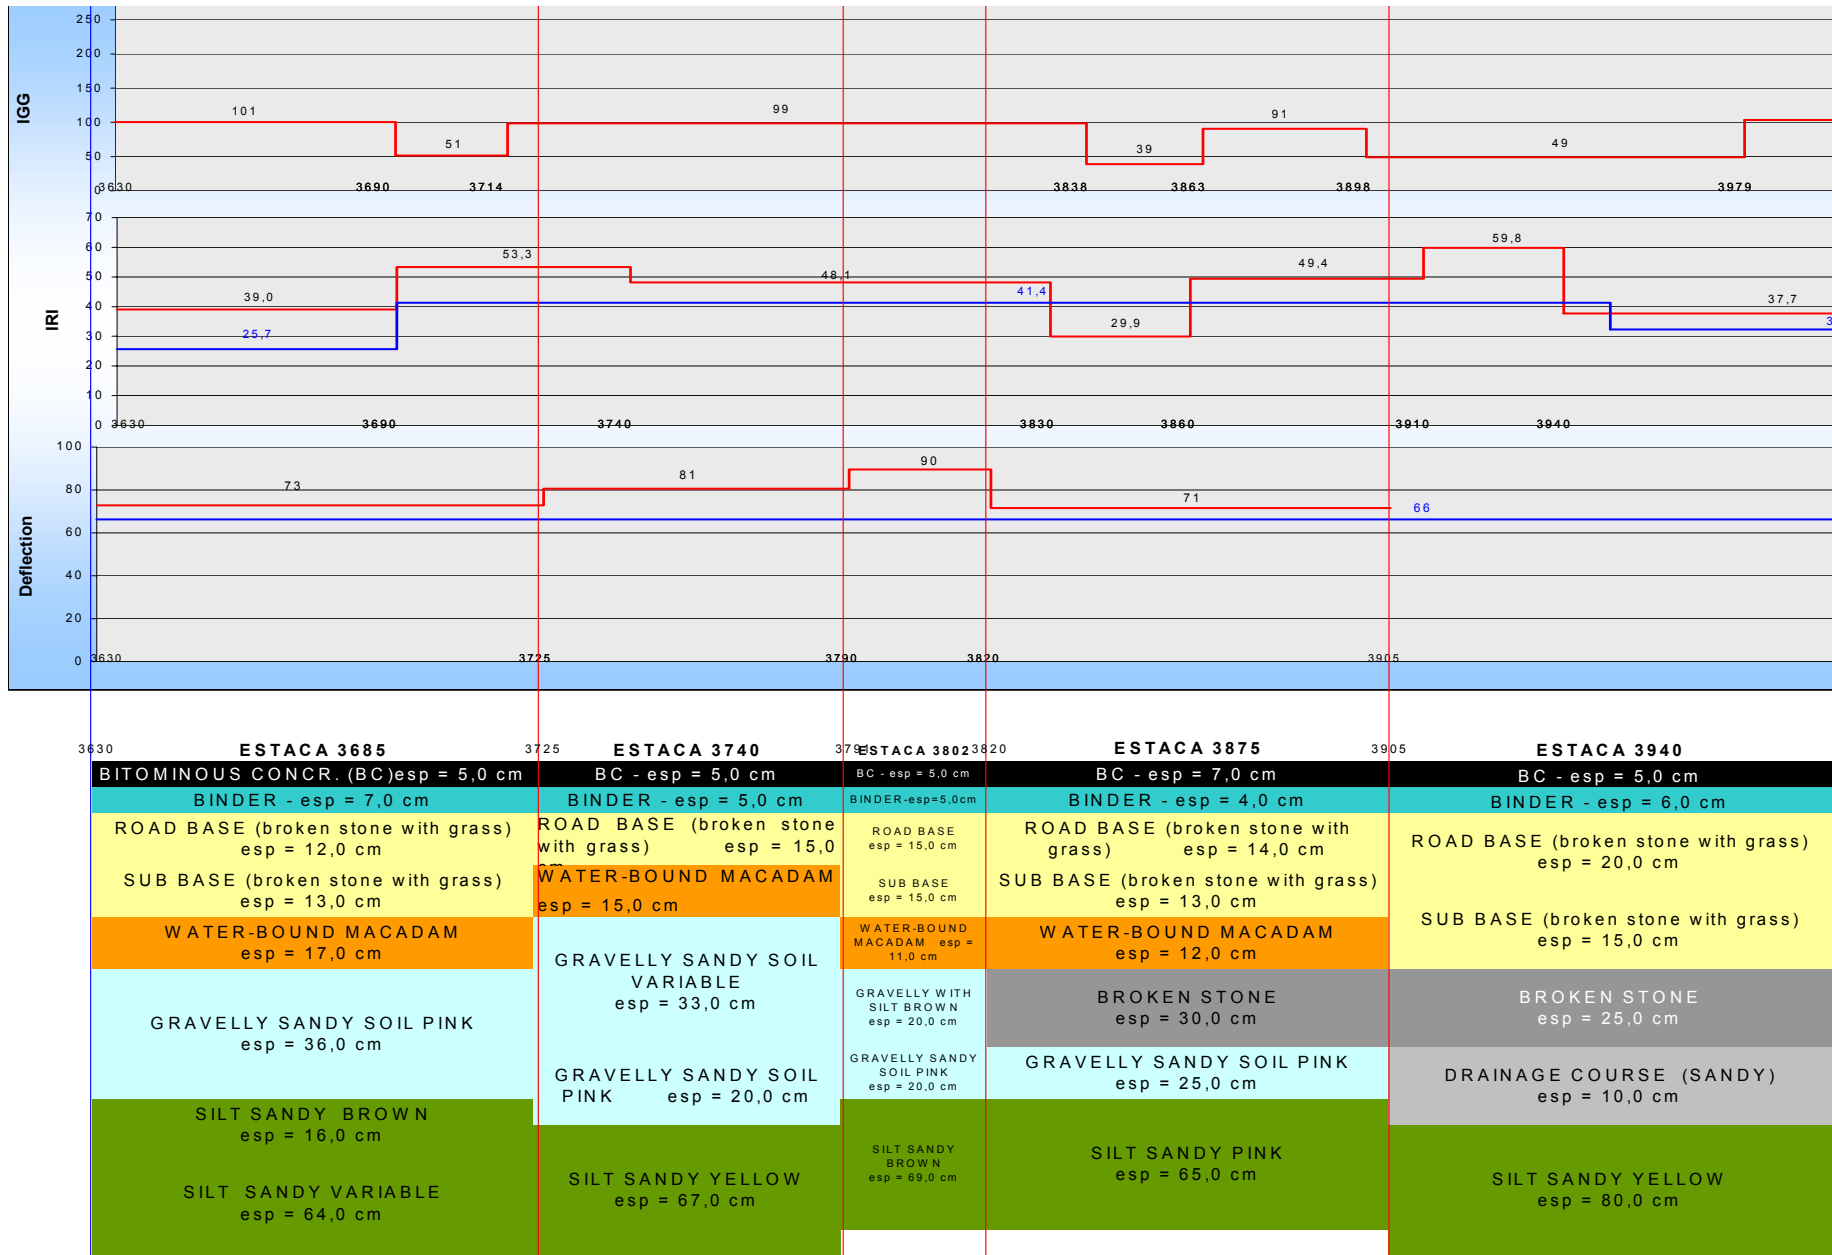
Restoration- graphic of pavement

From the information previously mentioned, it became evident that:

a) There were serious problems of pluvial waters confinement in different segments. Those problems were sensibly analyzed and resolved so satisfactory results could be obtained in the future restoration.

c) Some materials presented humidity "in situ" extremely above the optimum compacting humidity. This fact is pretty abnormal, considering the region's weather conditions. All researches made until now tropical regions indicate that the balance humidity of pavement constituent layers is an important rule, a little less important than the optimum humidity. The fact that layers with high water tenor have been observed on the BR-277 indicated that there were places where materials saturation is deriving from problems relatives to the level of the water table or the confinement of pluvial waters.

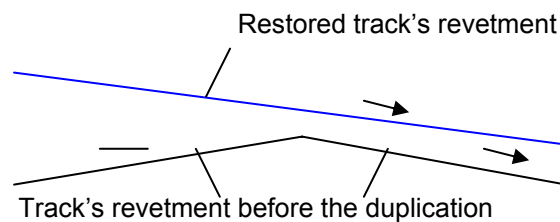
- Another factor observed is that, when the road's duplication was being executed, the existent track, which had camber, had its pavement restored with the execution of an additional layer of bituminous concret and had a modification in its transversal declivity to the external border of the transversal section, as shown in the following sketch:

In this situation, when there is an infiltration, through the revetment's sulcus, which had been deteriorated through the years, causes in determinate opportunities an accumulation of water near the border.

The consultants understood that, with the execution of the existent revetment reinforcement and implementation of a conservation/ maintenance system adequate to this occurrence should stop.

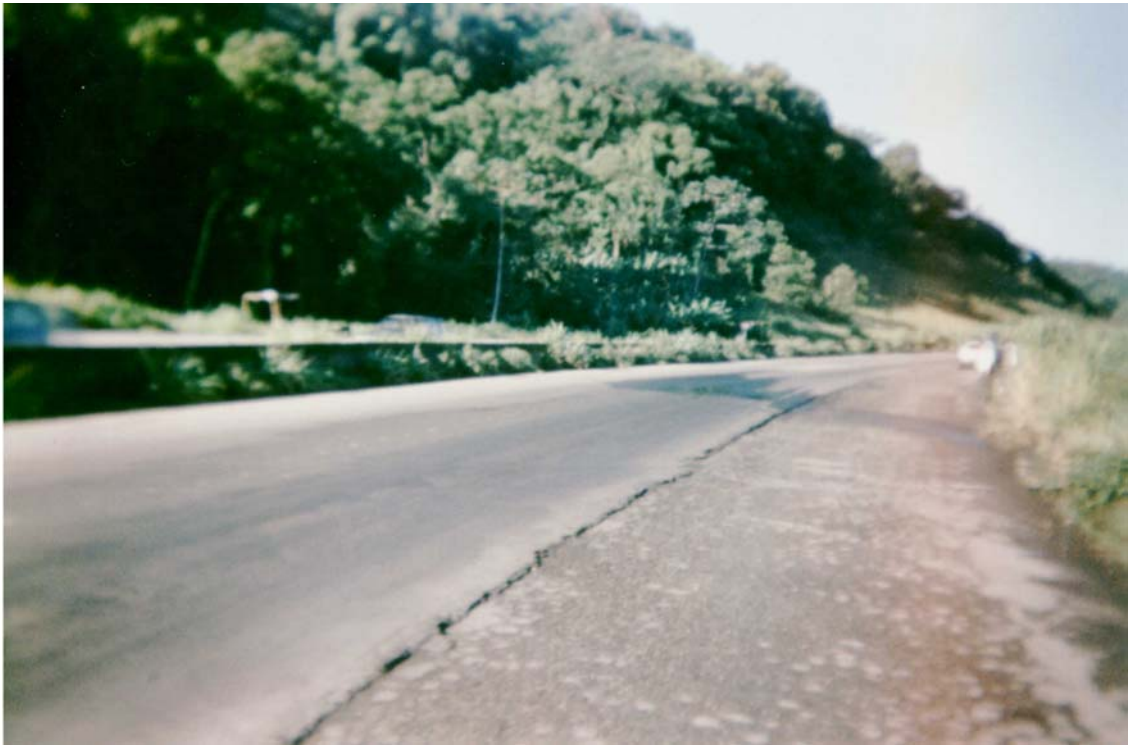
- The most relevant fact to be mentioned, about the water appearing in the revetment, refers to pertinent observations to the revetment's situation, which because it is found deteriorated in many places, permits precipitations to infiltrate, those flow off, obviously and naturally, through the biggest declivity trace, this makes that, in those segments where the longitudinal declivity is superior to the transversal declivity, precipitated waters infiltrate and flow off under the existent revetment, emerging when this geometric situation changes, this is, when the transversal declivity overcomes the longitudinal one. This situation was detected as the most critical in the segments between stakes 6240 and 7892 (track Curitiba-Paranaguá) and between stakes 1435 and 3093 (track Paranaguá-Curitiba). The mentioned situation, lasts during 3 days at most after precipitations, being that, in those cases is observed the appearing of marks in the revetment referring to a carrying of tiny particles from base and/ or sub-base pavement layers.

- The existence of places with water appearing under the revetment occurs specially in landfills, in other words, it doesn't occurs only on sections in cut, what, if occurred, could, at first, that the provenience of those waters was due only to the phreatic water sheet,

View of a BR-277/PR segment with water emerging on the revetment (January 1999)

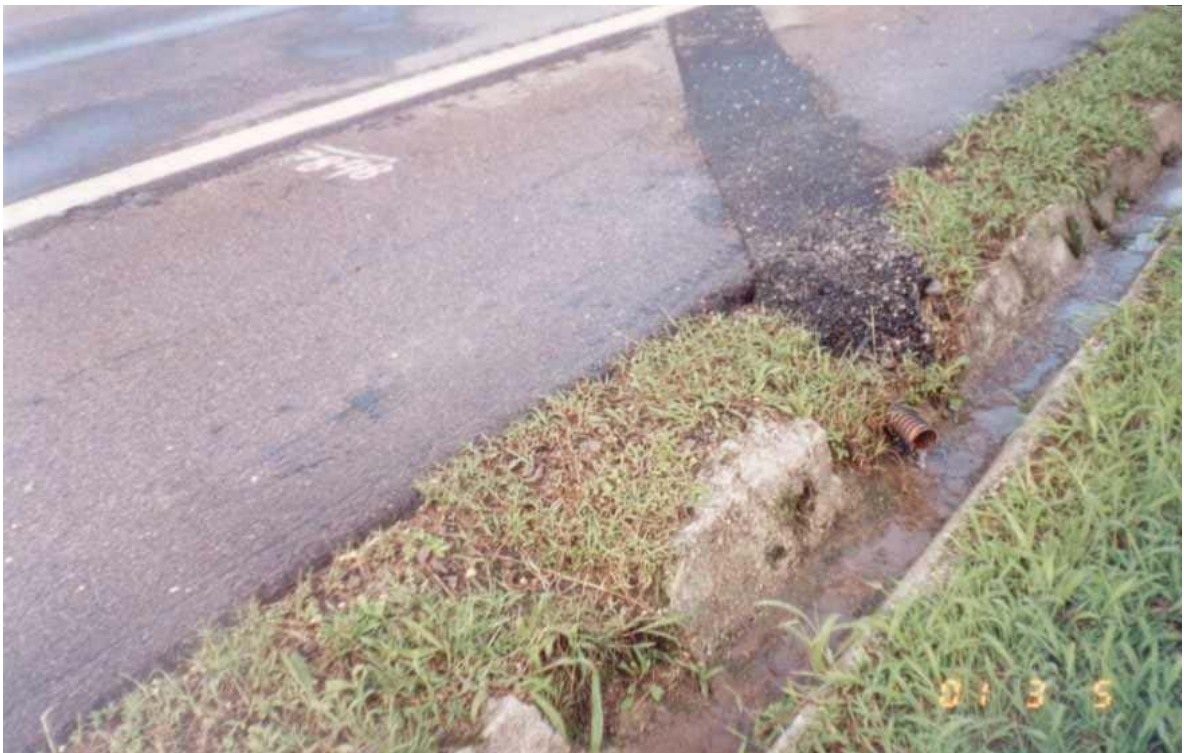
Detail of a transversal drain implemented with desembogue direct to the gutter

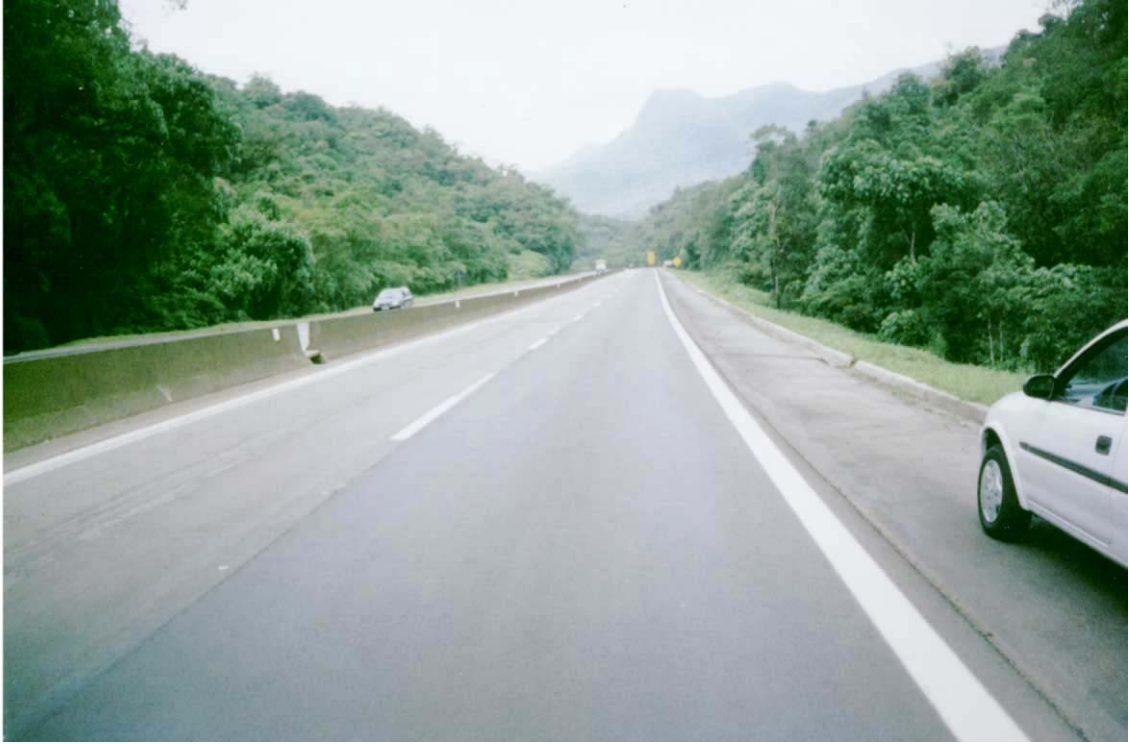
Detail from the local, placed in a segment that suffered intervention with the implementation of pavement drain and pavement restoration (November 2003)
