# **GEOTECHNICAL ACCIDENT AT KM 87 OF FEDERAL ROAD BR-116/RJ – TERESOPÓLIS- BRAZIL – CAUSES ANALYSIS AND RECONSTRUCTION SOLUTIONS**

*Sciammarella, José Carlos – Professor at Federal Center of Technological Education of Rio de Janeiro (CEFET-RJ) / Collaborator of CRT Concessionária – [projetosrj@yahoo.com.br](mailto:projetosrj@yahoo.com.br)*

This technical paper's objective is to present causes analysis of a geotechnical accident occurred at km 87 of road BR-116/RJ, as well as shows the proposed solutions to recover road body and the location current status.

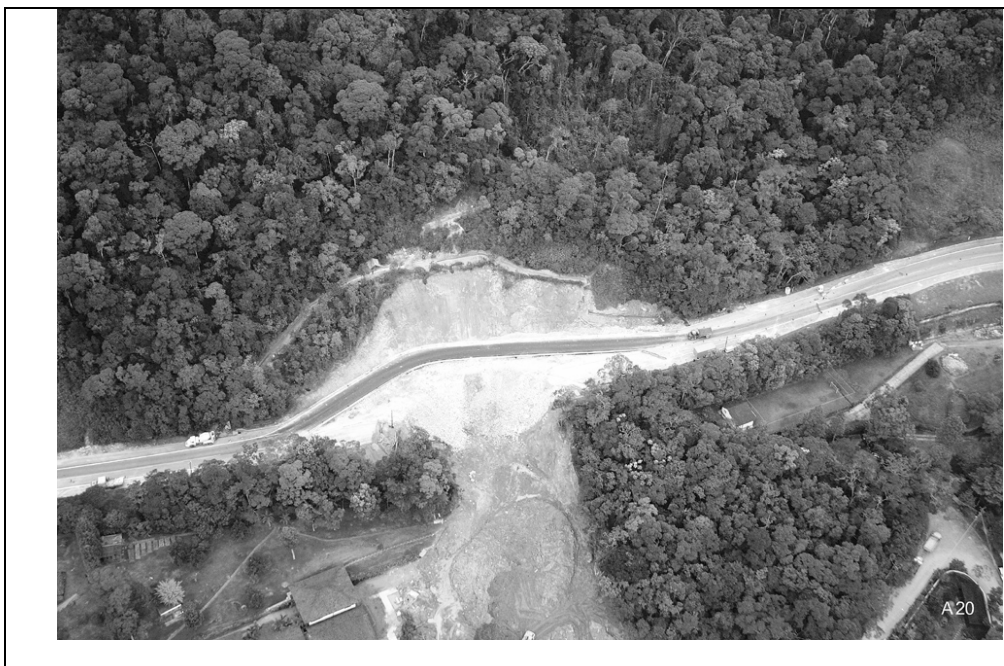
In the dawn of February 8<sup>th</sup>, when the traffic was little and the rain stopped pouring, a collapse of the soil that formed the road body happened. At that moment, there were two vehicles that were dragged by the soil mass and the water slide. The soil mass also reached several houses close to the road, severely damaging some of them.

**Figure 1 – A view from the land sliding location, already with a detour for temporary traffic**

It was provided the placement of small barriers on the road, in order to block the water reaching the slide area, extending its dimension. At the same time, it was started the distribution of granular material (cobble) on the slide region, in order to retain in. It also was necessary to create a detour to be used by light vehicles, once the road was closed.

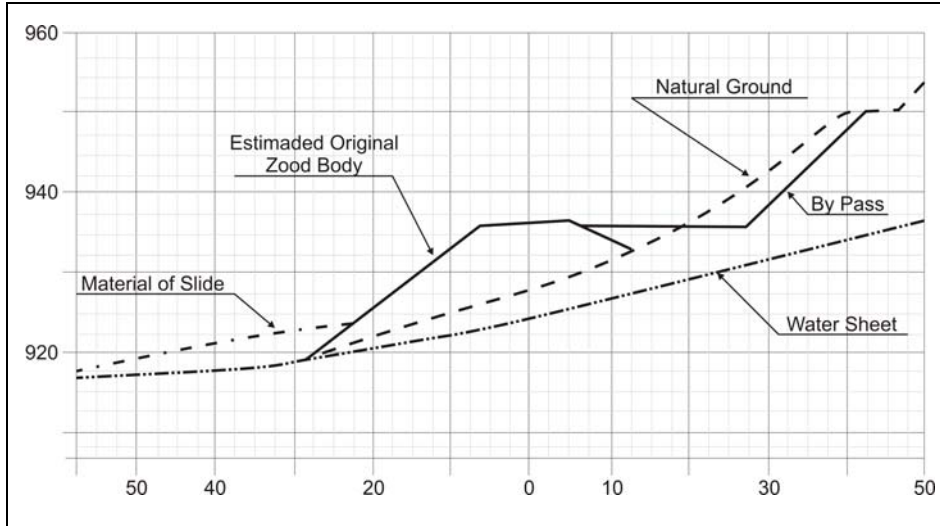
- b) The existence of an earth fill layer made with silty clay soil with a 5cm thickness was verified and under this layer there was a 10cm thickness layer of silty thin sand, probably a part of the natural terrain. The rupture's depth coincided with the bottom of this sandy layer;

- c) On figure 2 are water levels elevations observed on soundings. The hydraulic load is variable according to the measurement point and it clearly shows an uphill flow gradient to the slope's downstream. The flow gradient between February 21 and February 26 was around 0.2. Considering a permeability of  $10^{-5}$  m/s (thin sand permeability) there is an increase on the percolation front of 0.17m per day;

**Figure 2 – Cross section representing land sliding at km 87**

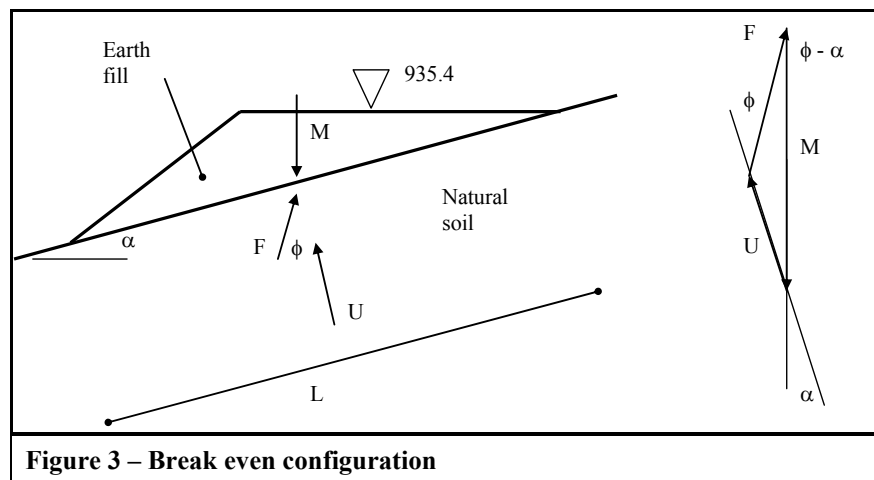
f) Based on the cross-section obtained (Figure 2), the hydraulic load was calculated on underground water capable of collapsing the earth fill. By the calculations made, the rupture value should correspond to the hydraulic load at elevation 935,7 in the road's level. This value is perfectly compatible with water level measurements and with local habitants statements about water accumulation upstream on the track on the accident's day (the water level should have increased up to this elevation, promoting its surgency). Water flows downstream the earth fill's bottom before and after the accident also showed high underground water pressure when the accident occurred. This way, we have a consistent diagnosis showing that the sub pressure made by water was the rupture's main cause. The calculations presented below prove the statement mentioned above. Considering figure 3, inserted below, we have at collapse's imminence:

It's possible to conclude that  $h_{total} = 935,7\text{m}$  (hydraulic load which would lead to lead to earth fill's rupture) matches the road's gradient elevation
