# A new technique to increase the safety of stone pavements through controlled evolution of unevenness

Crispino M. Professor, DIIAR - Road Infrastructures, Polytechnics of Milan (IT)

Papetti M. Chief of Road Maintenance Division, Municipality of Milan (IT)

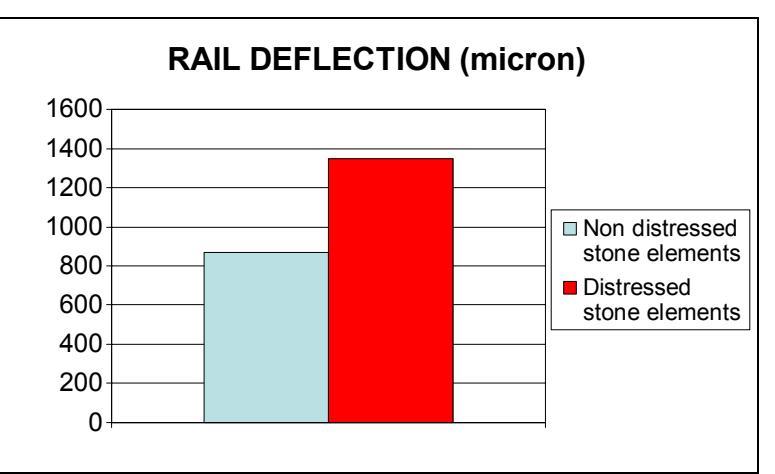
Figure 5. Average deflection of rails for deteriorated and non-deteriorated pavement surfaces [5]

The FWD measurements on rail confirmed the correlation between deflection of the rails (under the tram load) and degradation of the nearby pavement (fig. 5).

Specifically, in points where the rail deflected by less than 900 micron, at maximum load of 51 kN, no deterioration of the adjacent pavement was found. The conditions of the subgrade were good enough to bear the load without high deformation of the sleepers.

Where the rails deflected more than 1000 micron, adjacent stone pavement resulted already deteriorated (the subgrade bearing capacity was inadequate).

There is an intermediate range of deflection between 900 and 1000 micron, where it is more difficult to make predictions. These values were in fact measured both where the pavement had deteriorated and where it was still intact.

Vertical displacement is therefore a fundamental parameter to assess the suitability of an infrastructure with stone pavement and should therefore be used to plan maintenance operations.

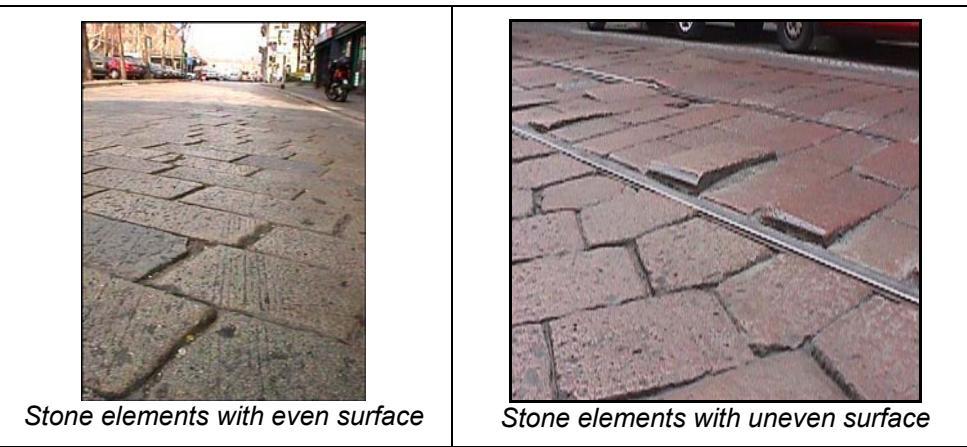
The most important factor, however, seems to be rainwater. Due to the large quantity of fines under the stone, the rainwater does not drain off but accumulates at the bottom, forcing materials out. This action generally follows the cyclical movement of the sleepers caused by the trams. Bibliographical research and site inspections showed that the deterioration of stone pavement (fig. 6) seems to be caused, particularly close to the tracks, by the movement of sleepers causing pumping of the fine materials in the joints, in the sand bed and in the subgrade foundations [5].

Figure 6. The surface of deteriorated stone pavements

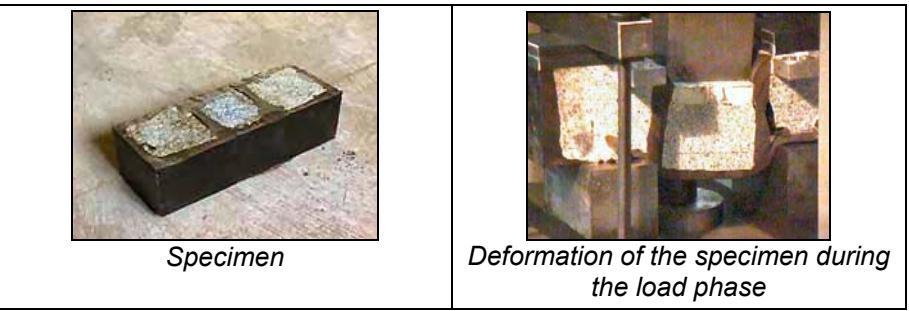
The test was carried out in controlled load conditions. The load leading to the first detachment of the resin was 11,124 kN. At this load the average displacement was 15 mm.

The joint finally got under rupture at 13,181 KN (fig. 8).

Figure 8. Shear test for a joint sealed with polyurethane resin

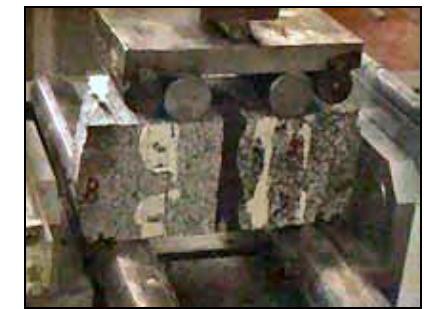
Figure 9. Sample subjected to bending strength

During this test the maximum force reached was 17 kN. Tensile at the base of the sample generated a bending force just before rupture of 4.06 MPa [9]. Here too, the strength matches the manufacturer's specifications (about 4 MPa).

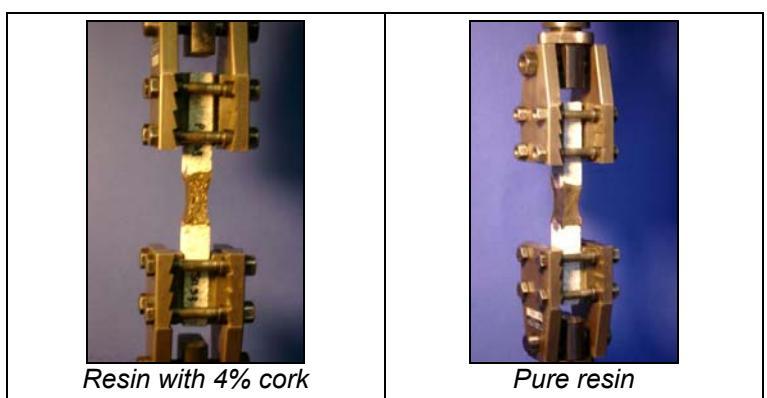
Figure 10. Polished stone samples with polyurethane resin, with and without cork

- fracture begins at the contact interface between the resin and steel or stone prism,
- subsequently the crack extends cohesively through the resin.

The fracture is practically cohesive (in the resin), whereas in adhesive fractures the primer and resin detach first.

In stone samples the fracture frequently begins with the detachment ("ripping") of small pieces of stone which break due to the tensile at the interface and stay glued to the resin.

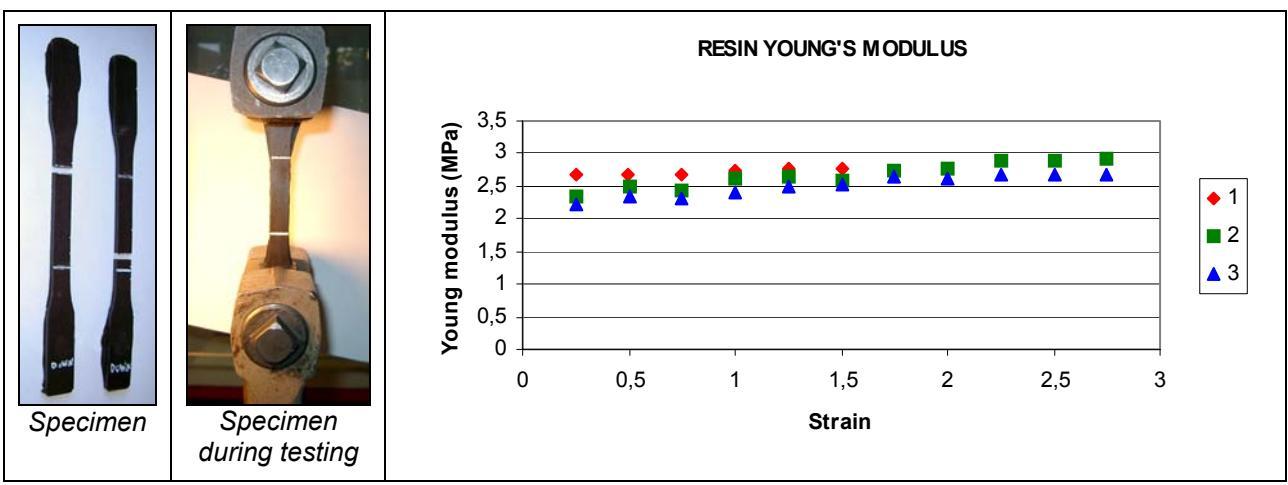
The three samples behaved very similarly; nominal forces of about 2 MPa were found with a resistance force of about 8 MPa and deformation of about 300%, while the young modulus of elasticity was between 2.8 and 3 MPa.

Figure 11. Direct tensile strength test carried out on 3 samples of polyurethane resin

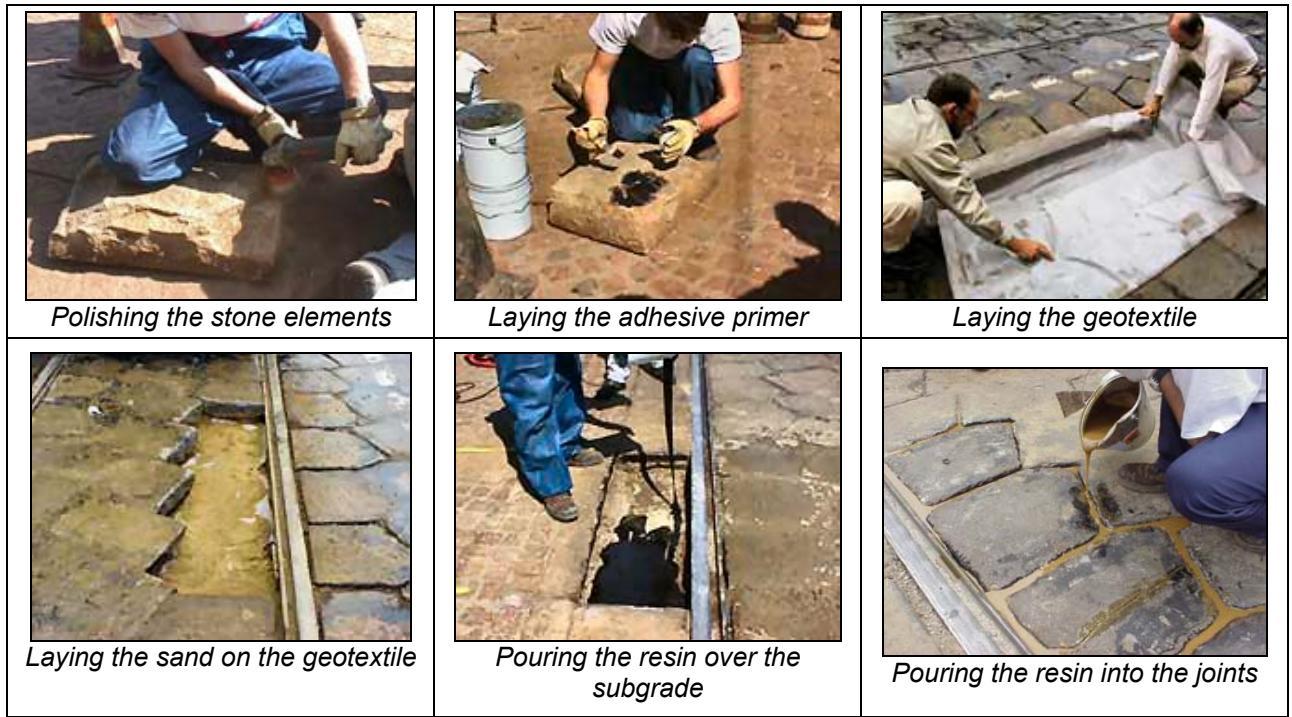
Figure 12. Installation of the stone elements with the new technique

- installation of the stone elements and knocking into place,

- filling the joints with resin.

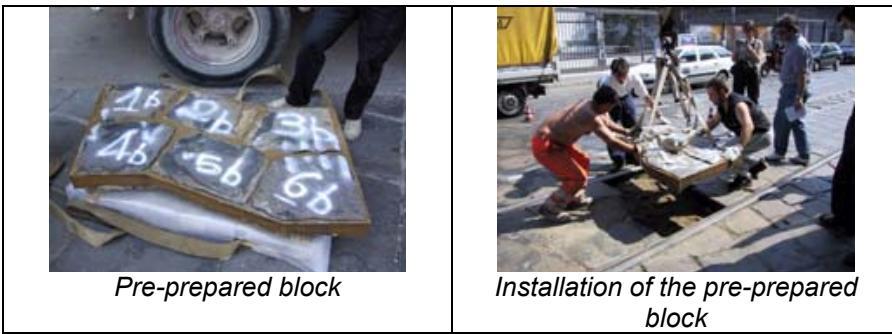
Figure 13. Installing the prefabricated block

After three months, visual inspections were carried out on site, and the pavement proved to be in a good state of repair; the stone blocks were properly located respect to the road surface and the tramway. The resin in the joints was perfectly adherent to the stone walls and was not aged.

It takes rather longer to prepare the stone elements than in conventional methods, mainly due to the polishing and cleaning process. In order to get round this problem, some blocks were pre-prepared in the lab (fig. 13). This speeded up the procedure, because it was necessary to prepare only the surfaces of the elements which had not been removed.
