# GPR Investigation of Cobblestone Road Pavement Degradation

S. Colagrande

## Synopsis

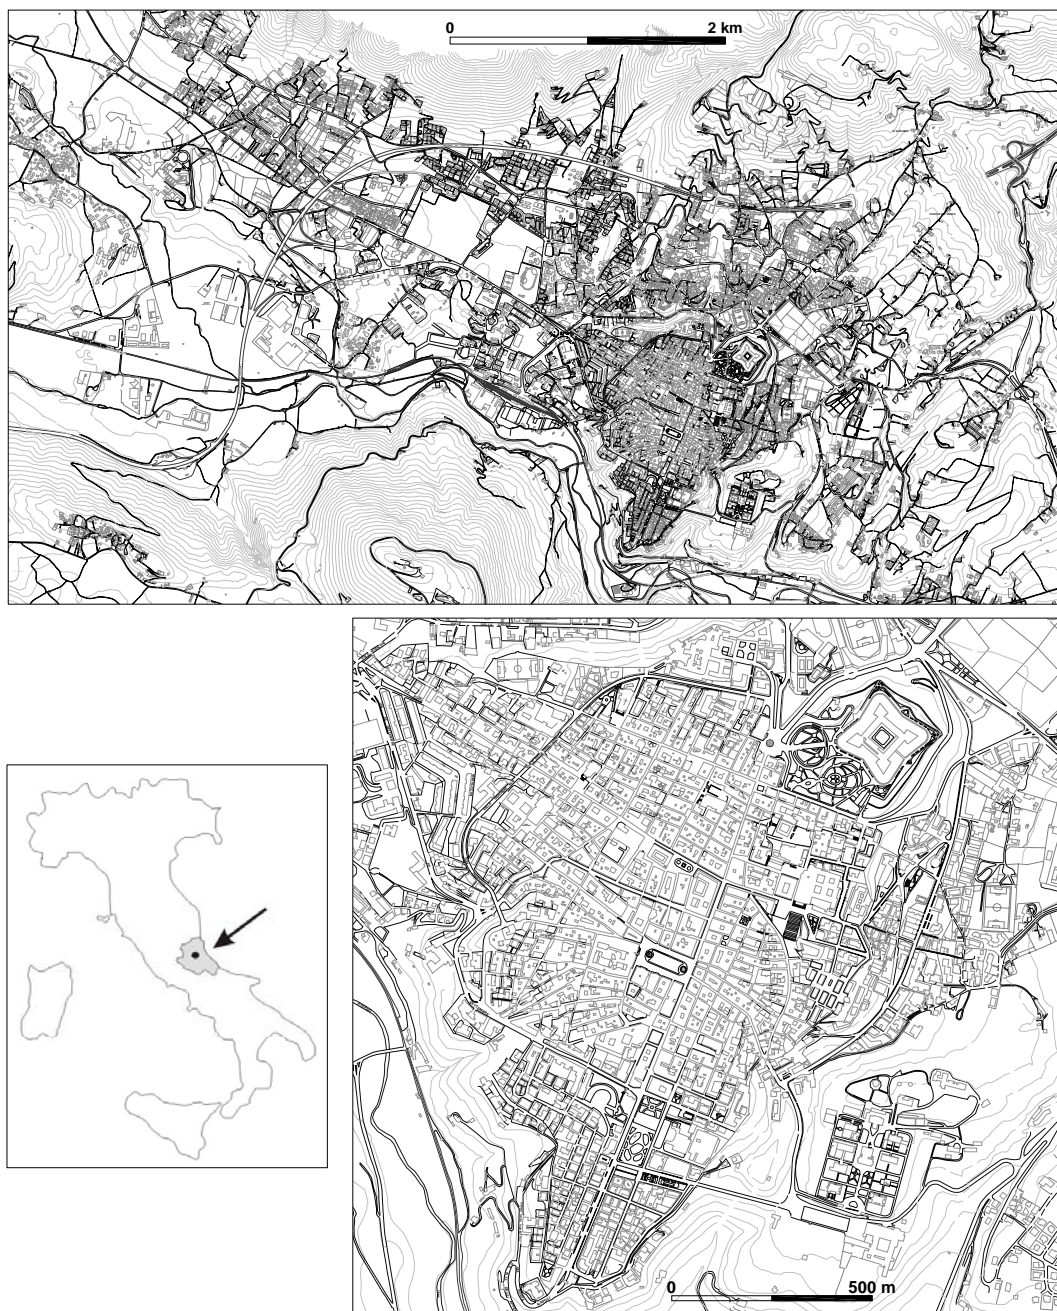
Figure 2: Investigated area and layout of the historical center of L'Aquila

All the investigated road pavements consist of cobblestones and are located in the historical center of L'Aquila (Abruzzo Region – Italy) (Figure 2).

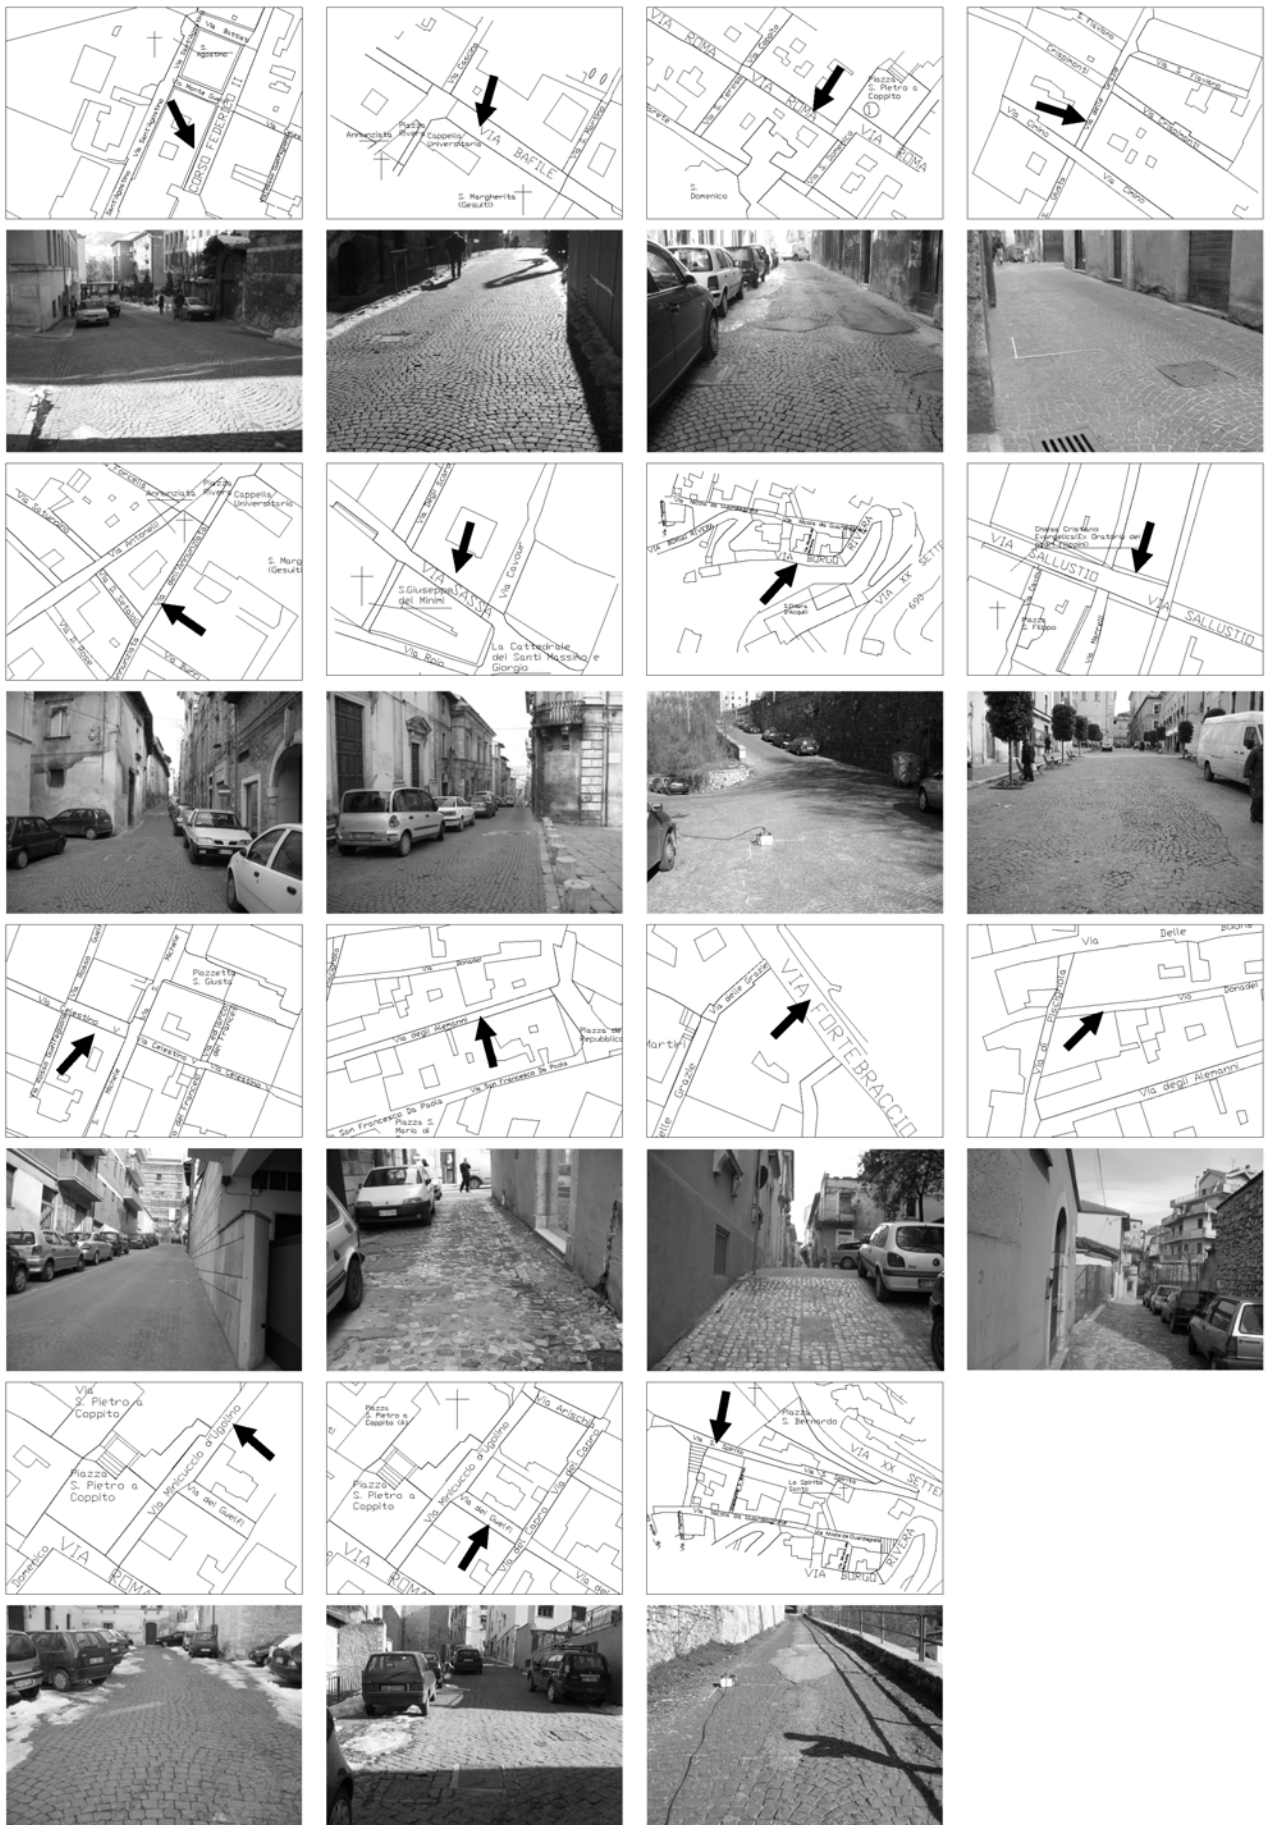
Figure 3: The 15 investigated sites

With a view to finding correlations between all the investigated variables (type of stone pavement, traffic load and pavement surface degradation), 15 sites were taken into consideration, after a thorough analysis of all the roads in the historical center of L'Aquila. The 15 sites were selected in such a way as to represent of different combinations of the investigated variables. Figure 3 shows the images of the 15 sites, while Table 1 displays the identification data of all the sites, as well as the values assigned to the variables.

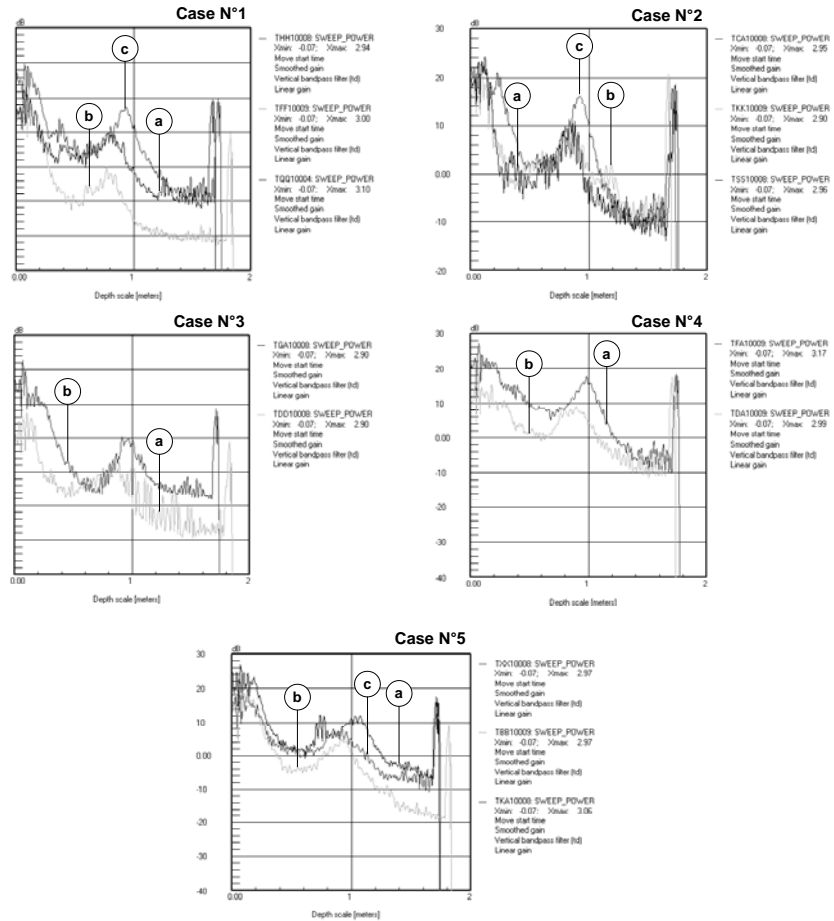
Figure 5: Sweep power of pavements grouped by level of degradation

Figures 4 and 5 exhibit the sweep mean and sweep power diagrams of the five combinations shown in Table 2. In the table, each road is associated with an alphanumeric code, which is found also in the corresponding diagram.

Comparing the results of the sweep mean diagrams yields a recurrent sequence between the three levels of degradation (a: no degradation; b: average degradation; c: high degradation). In areas where the road is degraded, a reflected signal is almost always recorded. This signal, which is picked up by the receiver antenna, has higher values than the ones of less degraded roads. A single exception is combination n° 5 (between Via Santo Spirito and Piazza San Pietro), where signals are inverted. The analysis of sweep power diagrams shows that they are fairly consistent with the considerations made above for the sweep mean diagrams.

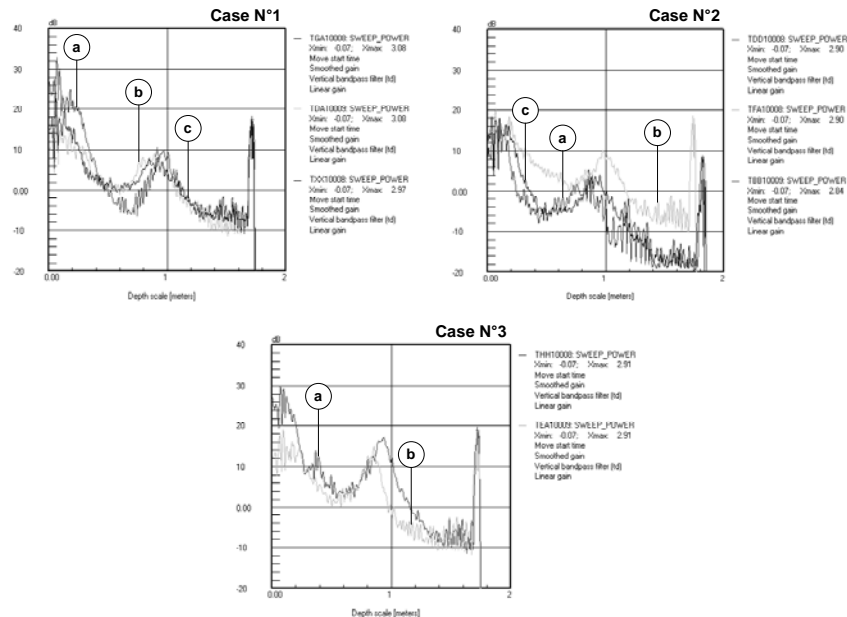
**Figure 7: Sweep power of pavements grouped by type of stone**

Figures 6 and 7 display the sweep mean and sweep power diagrams, respectively, of the three combinations shown in Table 3. In the Table, each road is associated with an alphanumeric code, which is used also in the corresponding diagram.

Comparing the results of the sweep mean diagrams gives a recurrent sequence between the three types of stone pavement (a: porphyry; b: limestone; c: leucitic lava). Porphyry pavements have a more marked reflection of electromagnetic waves than limestone and leucitic lava ones. This finding is less evident in combination n° 2, namely on Via Sallustio (porphyry pavement). The analysis of sweep power diagrams shows that they are in fairly good agreement with the considerations made above for the sweep mean diagrams, and the anomaly detected in combination n° 2 is enhanced.

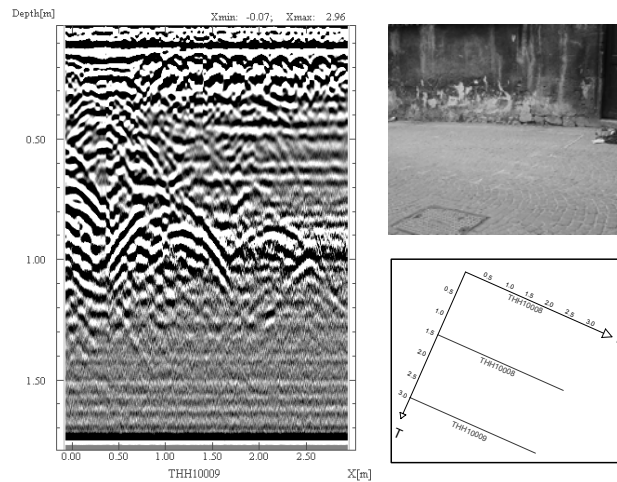
Figure 12: Deep radar discontinuity on Via Santo Spirito

With regard to the second point, the investigation identified very deep discontinuities in the following three roads: Via Sassa, Via degli Alemanni and Via Santo Spirito. These roads are the same as those having a high number of underlying utility grids and a high level of degradation. Figures 10, 11 and 12 display the radargrams obtained from the above-mentioned three roads, whose discontinuities lie at a depth of 2-3 m from the road surface. Also in this instance, the high degradation of the road pavements depends on the lack of a homogeneous subbase and on inadequate compaction of the deep layers.
