The Savone Bridge on the SS 7 “Appia”: Real Time and Topographic Monitoring of Thermal strain

Abstract

problem explanation

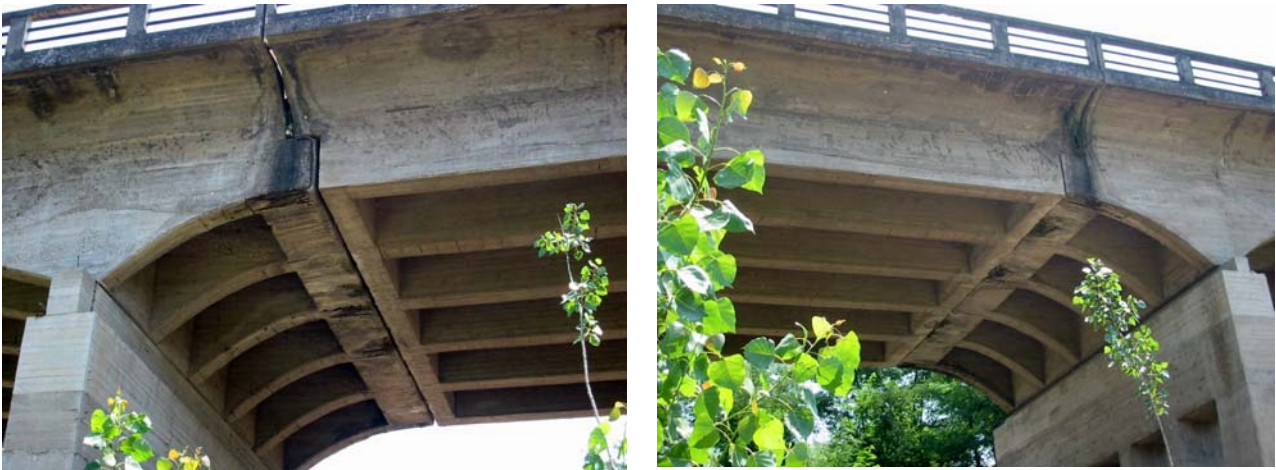
The whole bridge has been ordinary maintained in the past. Typical works made on it were: new final layer of pavement, installation and maintenance of new metal guard rail, maintenance of the drainage devices and of the expansion joints. Talking about the uncommon maintenance, just one work on the two piers in the river has been made: it had been observed expulsion of small parts of concrete from the lower part of the pier. Nowadays, an investigation on the spot was made together technicians of the management society (ANAS) and an unusual displacement of the first deck (on the Capua side) has been observed. The displacement is showed in pic. 1 (left); it can be compared to the other joint (right picture).

Picture 1: unusual displacement of the expansion joint on the first deck of the Savone bridge

The displacement provoked an excessive run of the expansion joint: of course it lost its functionality. So,, works of uncommon maintenance had to provide the replacement of the expansion joint itself but it was decided that investigations concerning causes of the trouble had to be made with the installation of a system of monitoring. The system was based on both topographic and satellite procedures in order to avoid unuseful works.

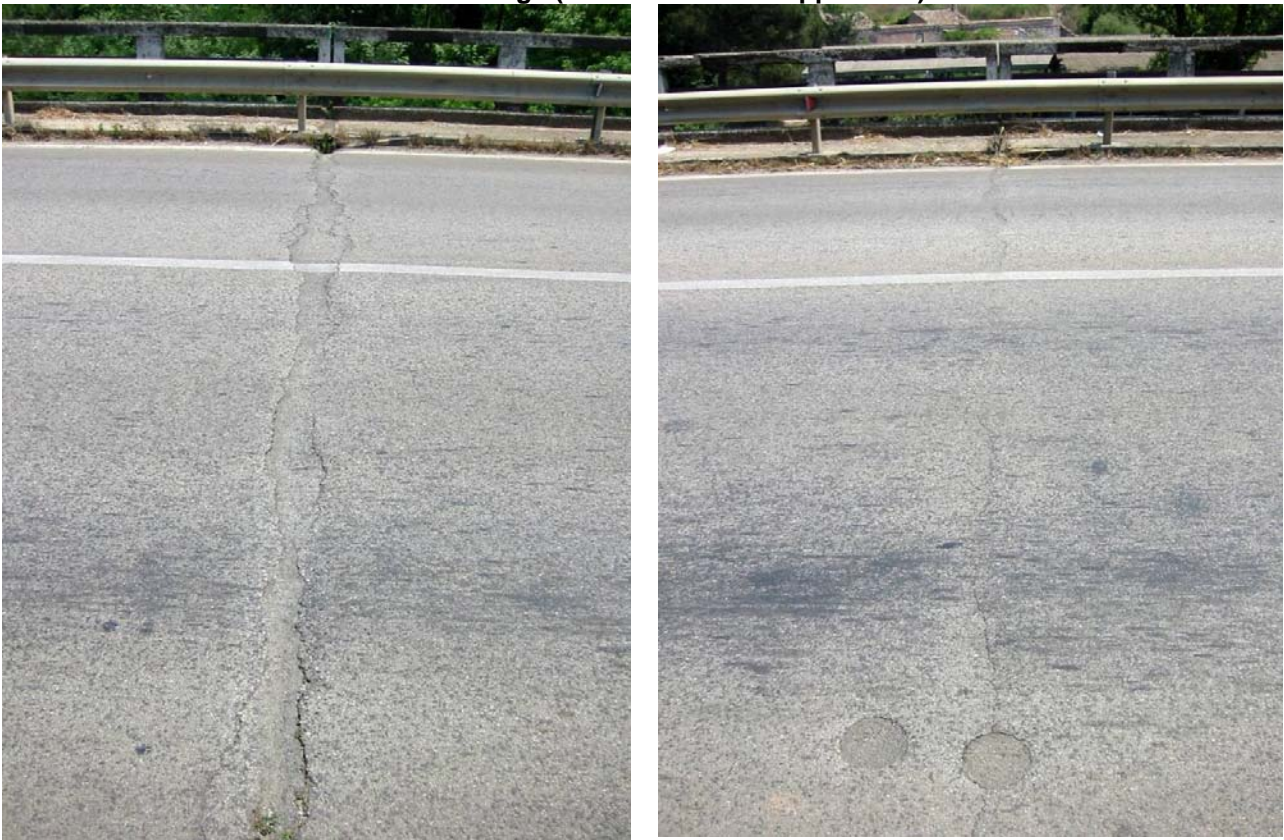
Picture 2: unusual displacement of the expansion joint on the first deck of the Savone bridge (as seen from the upper side)

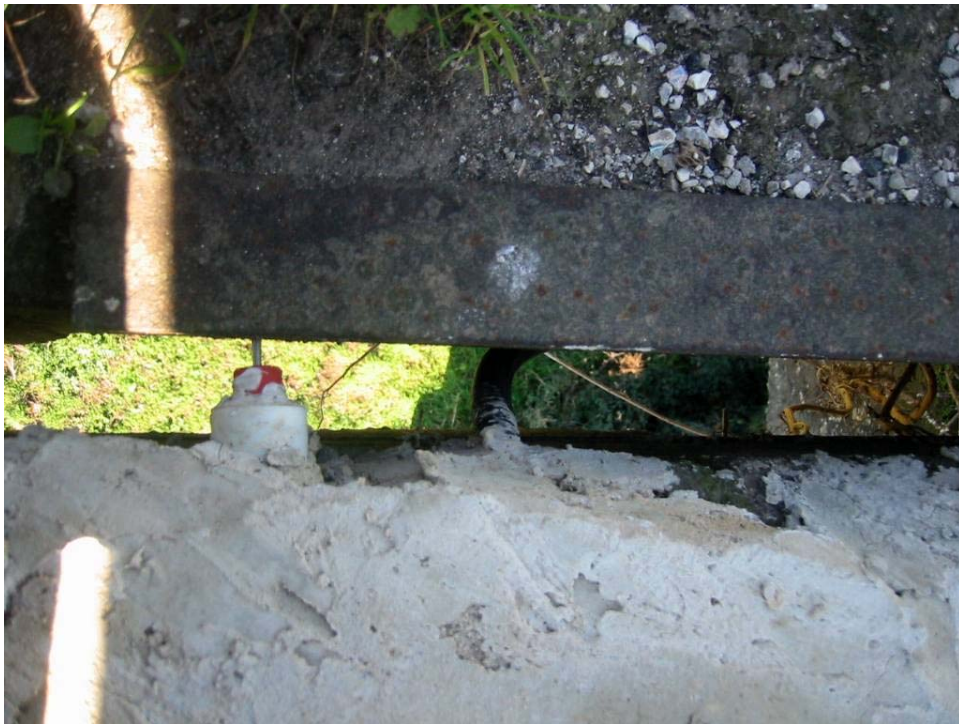
The gauges have been installed inside a protective plastic shell (see picture 3).

Picture 3: linear expansion joint gauge installed

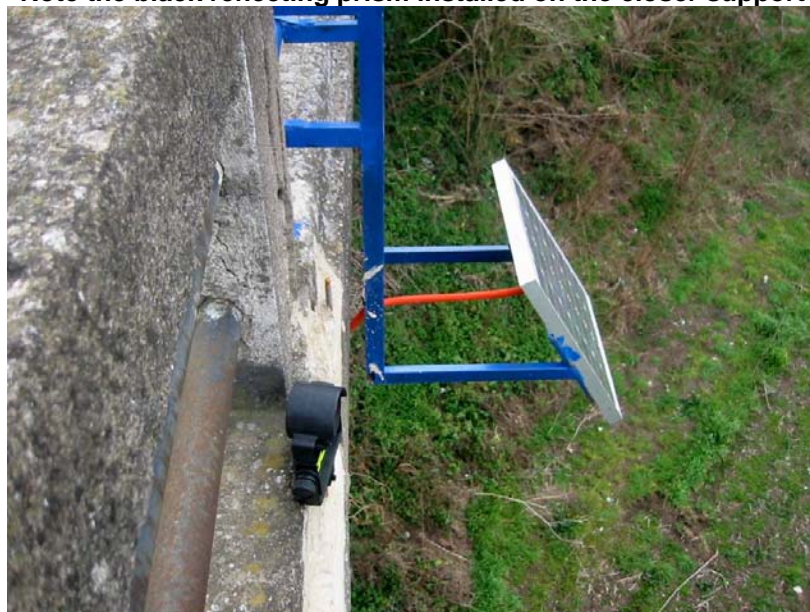
**Picture 4: in this picture the solar panel and the topographic supports are visible.
Note the black reflecting prism installed on the closer support**

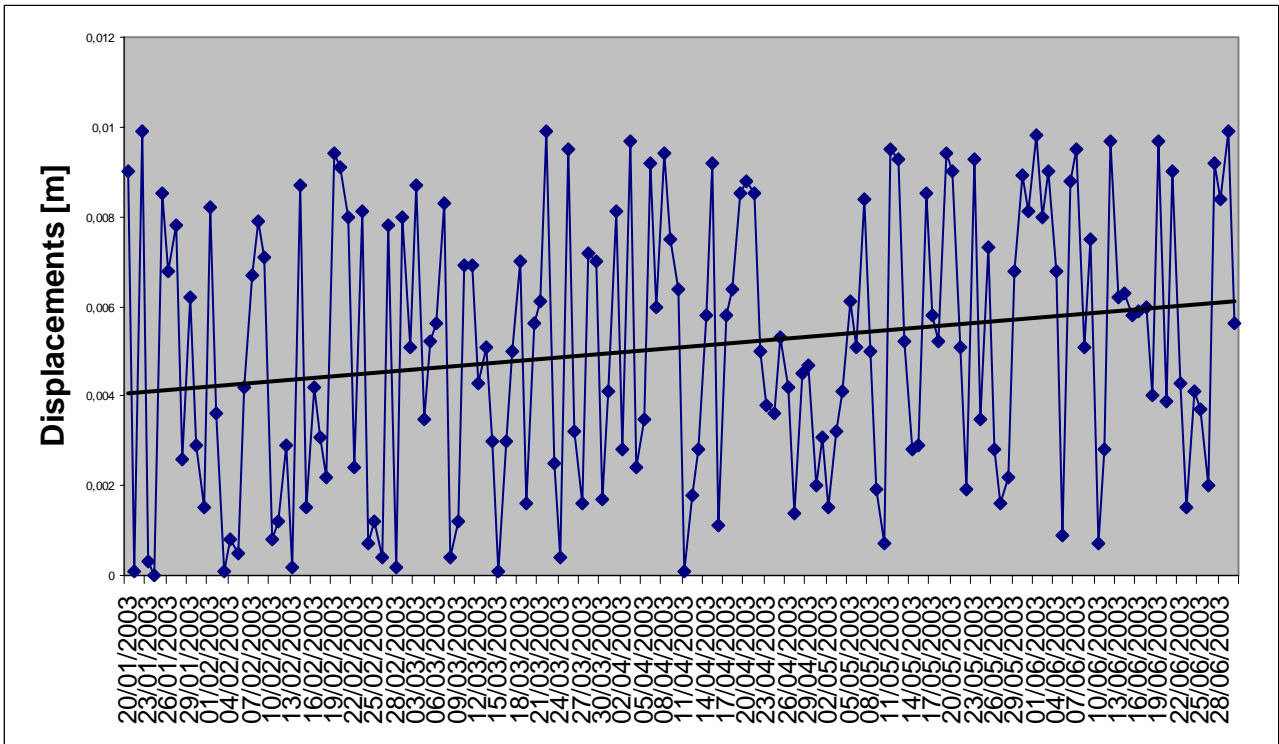
Fig. 5: Results gauge S1

The analyses of diagrams shows the following matters. The gauge 1 showed a lengthening so the 2 heads of the bridge moved away during the period of observation. Gauges 2 and 3 showed a shorten so the 2 heads of the bridge approached during the period of observation. Gauge number 4 resulted substantially stable. The strain of gauge 1 is besides suitable with the trend of topographic survey as it showed a moving away of the 2 heads of the bridge.
