Means to Reduce Operating Speeds on Curves

Nikiforos Stamataidis, Ph.D. P.E.
Professor – University of Kentucky

SYNOPSIS

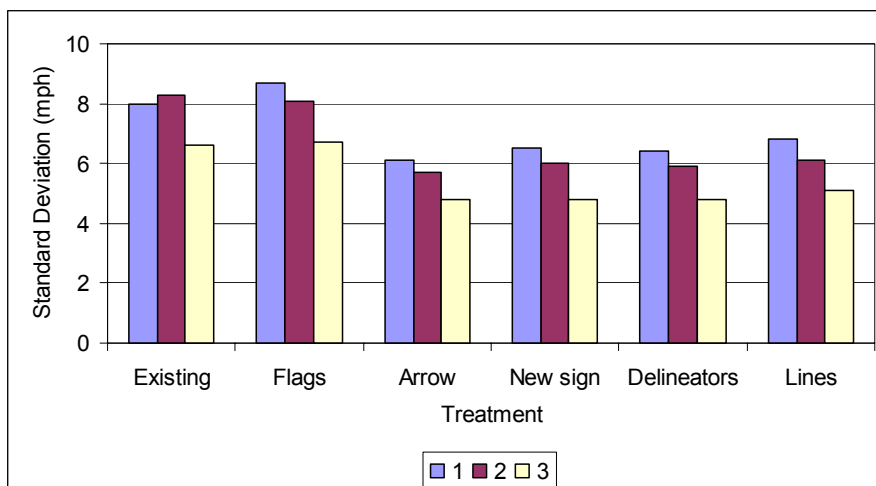
Figure 1 Standard deviations by measurement point (mph)

Ideally, the standard deviations associated with these treatments should decrease as vehicles travel through the curve. Treatments with smaller standard deviations have more than likely forced drivers to navigate the curve at a safer speed, which in turn decreases the range of speeds and the variance. It can be assumed that treatments with smaller standard deviations have vehicles operating in a safer manner, since there will be little difference between speeds. Even though the existing treatment had smaller average speeds when compared to the other treatments, Figure 1 shows that its standard deviation is much larger than the other treatments. The treatments have not decreased the average speeds, but they have considerably decreased the standard deviations and thus resulted in more consistent operating speeds.

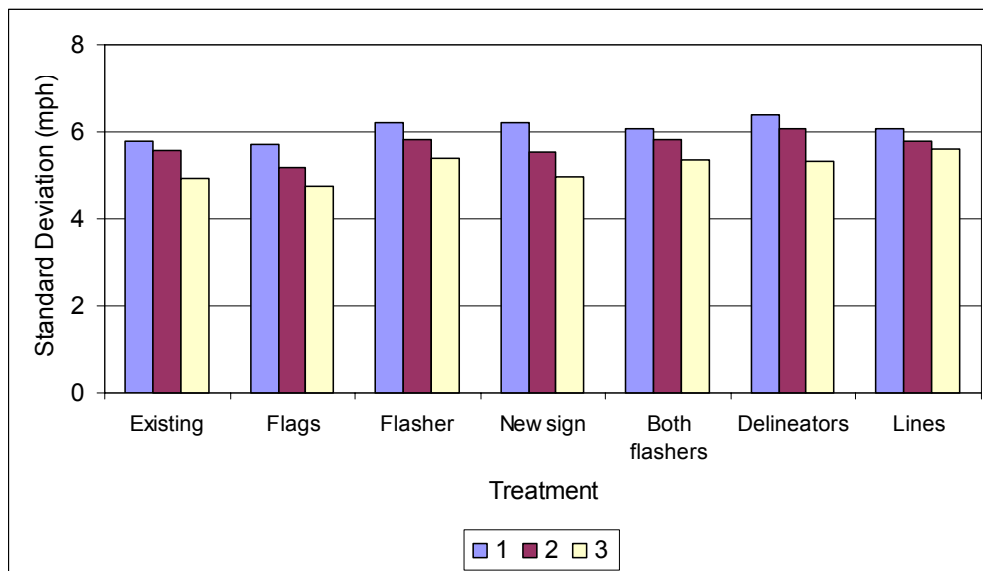
Figure 3 Speed standard deviations by measurement point

The data in Table 4 indicate that the third measurement location experienced the largest overall speed reduction. Standard deviations also demonstrate the highest reduction at the same location (Figure 3). The statistical analysis performed focused on the third measurement location as well. The test for equal variances revealed that the average speeds and variances were not equal. The test for non-homogeneous variances revealed that the warning sign with flags, both signs with flashing lights, and the transverse lines significantly affected the average speed and variances. Therefore, it can be concluded that these three treatments had a direct impact on the reduction of speeds when compared to the existing conditions.

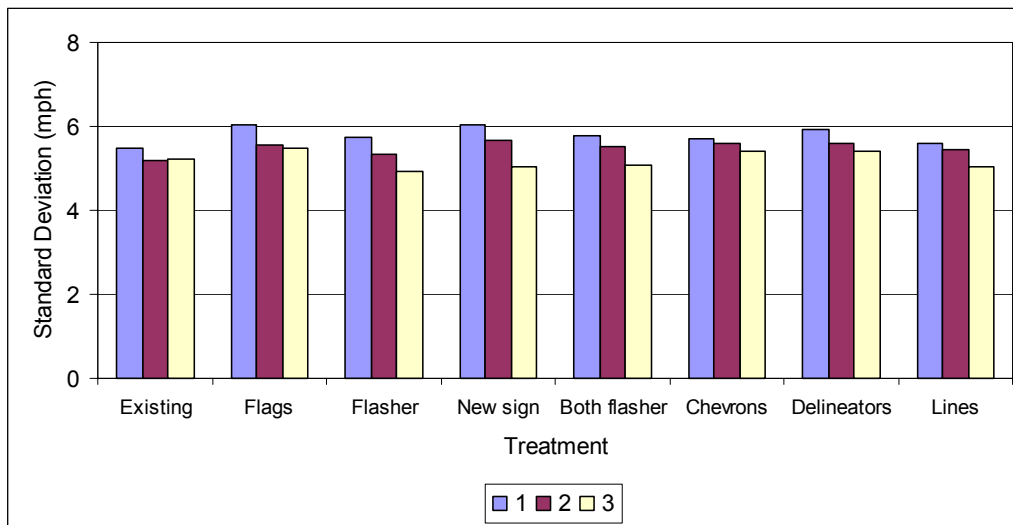
Figure 5 Speed standard deviations by measurement point

For this location the biggest changes in speed were noted at the second measurement location. Therefore, the statistical analysis was performed using the measured speeds from this location. The standard deviations showed larger changes at the third location and did not show any significant changes between the first and second measurement location for most of the treatments (Figure 5). The test for equal variances for the speeds of each treatment revealed that the average speeds and variances were not equal. The test for non-homogeneous variances revealed that the warning sign with flashing lights, the new combination warning sign, and both signs with flashing lights significantly affected the average speed and variances for this site. Therefore, it can be concluded that these three treatments had a direct impact on the reduction of speeds when compared to the existing conditions.

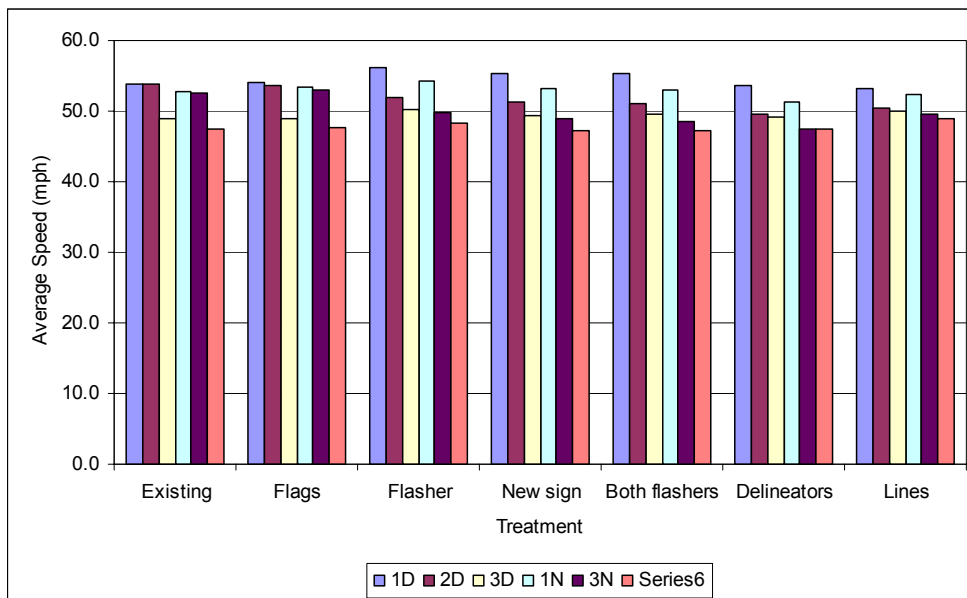
Figure 6 Average speeds by day (D) and night (N)

The time of day analysis showed similar overall results as noted in the other sites (Figure 6). An unexpected result was for the treatment of flashers where most speeds increased. During the daytime, this treatment essentially acts as the existing treatment would, considering the flashing lights do not flash during the day, but there was almost a 3% increase in speed for the nighttime, which does not correlate well with the previously observed results. Some promising readings to note are the nighttime average speed reductions for the warning sign with flashing lights (5.1%; 2.7 mph), the combination horizontal alignment/advisory speed sign (6.8%; 3.6 mph), and the flashing lights on both warning signs (7.5%; 4 mph).

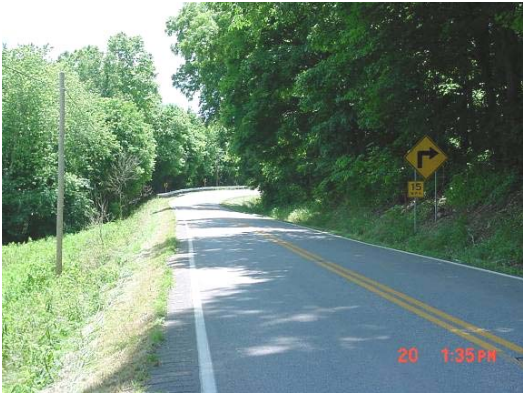
Typical existing conditions

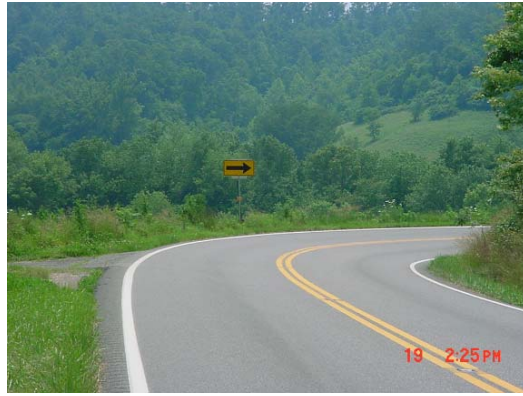
Large arrow

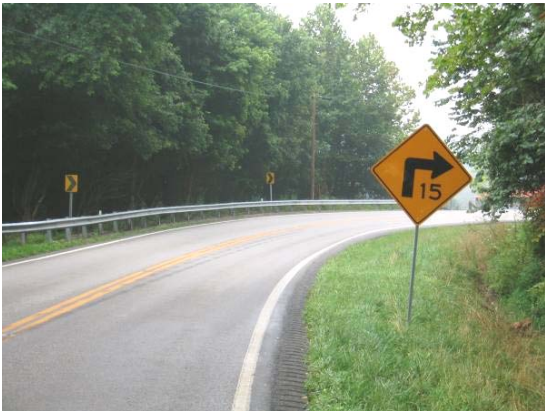
New combination sign

The combination horizontal alignment/advisory speed sign is a relatively new sign that combines the horizontal alignment sign with the advisory speed plaque onto a single sign. This sign is used to supplement the horizontal alignment sign with advisory speed plaque and is installed at the point of curvature, after the horizontal alignment sign. This signing reiterates the warning conveyed from the horizontal alignment sign as the driver approaches the curve. The sign duplication (2 warning signs) is envisioned to work as a stronger indication of the potential hazard. The one-direction large arrow sign is most commonly used to demarcate an upcoming change in the horizontal alignment of the roadway. The large arrow sign should be placed at the beginning of the curve, perpendicular to traffic. The sign should be placed at a location that allows the sign to be seen for a sufficient distance from the tangent of the curve. The ample distance will provide drivers an adequate amount of time to make a decision based on the change in alignment.

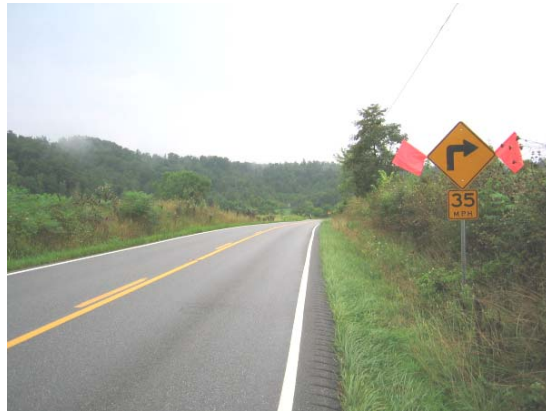
Warning sign with flags

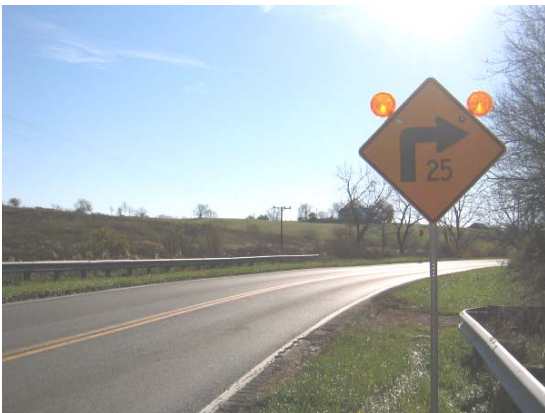
New combination sign with flashers

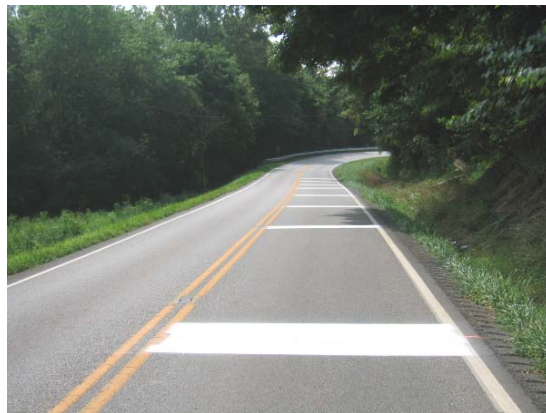
Transverse lines

Transverse pavement markings, or optical speed bars, are stripes located at horizontal curve tangents, roundabout approaches, intersection approaches, construction areas, and freeway off ramps (Meyers, 1999). The goal of transverse markings is to reduce speed and improve safety at potentially hazardous locations. The markings are placed in advance of the location in question and perpendicularly to the path of traffic, to decrease vehicle speed before the location is reached. The spacing between stripes is reduced and they decrease in thickness, as they get closer to the location (Griffin and Reinhardt, 1996). The purpose of these markings is to create an optical illusion, which would force drivers to slow down. The line spacing and size is intended to give the driver a sense of acceleration, regardless whether the vehicle is actually accelerating. This impression of acceleration will give drivers the indication they are traveling faster than intended, which in turn will force them to decrease their operating speed.
