Design and monitoring of a safe pedestrian crossing facility: via Venezia Giulia, Rome

SYNOPSIS

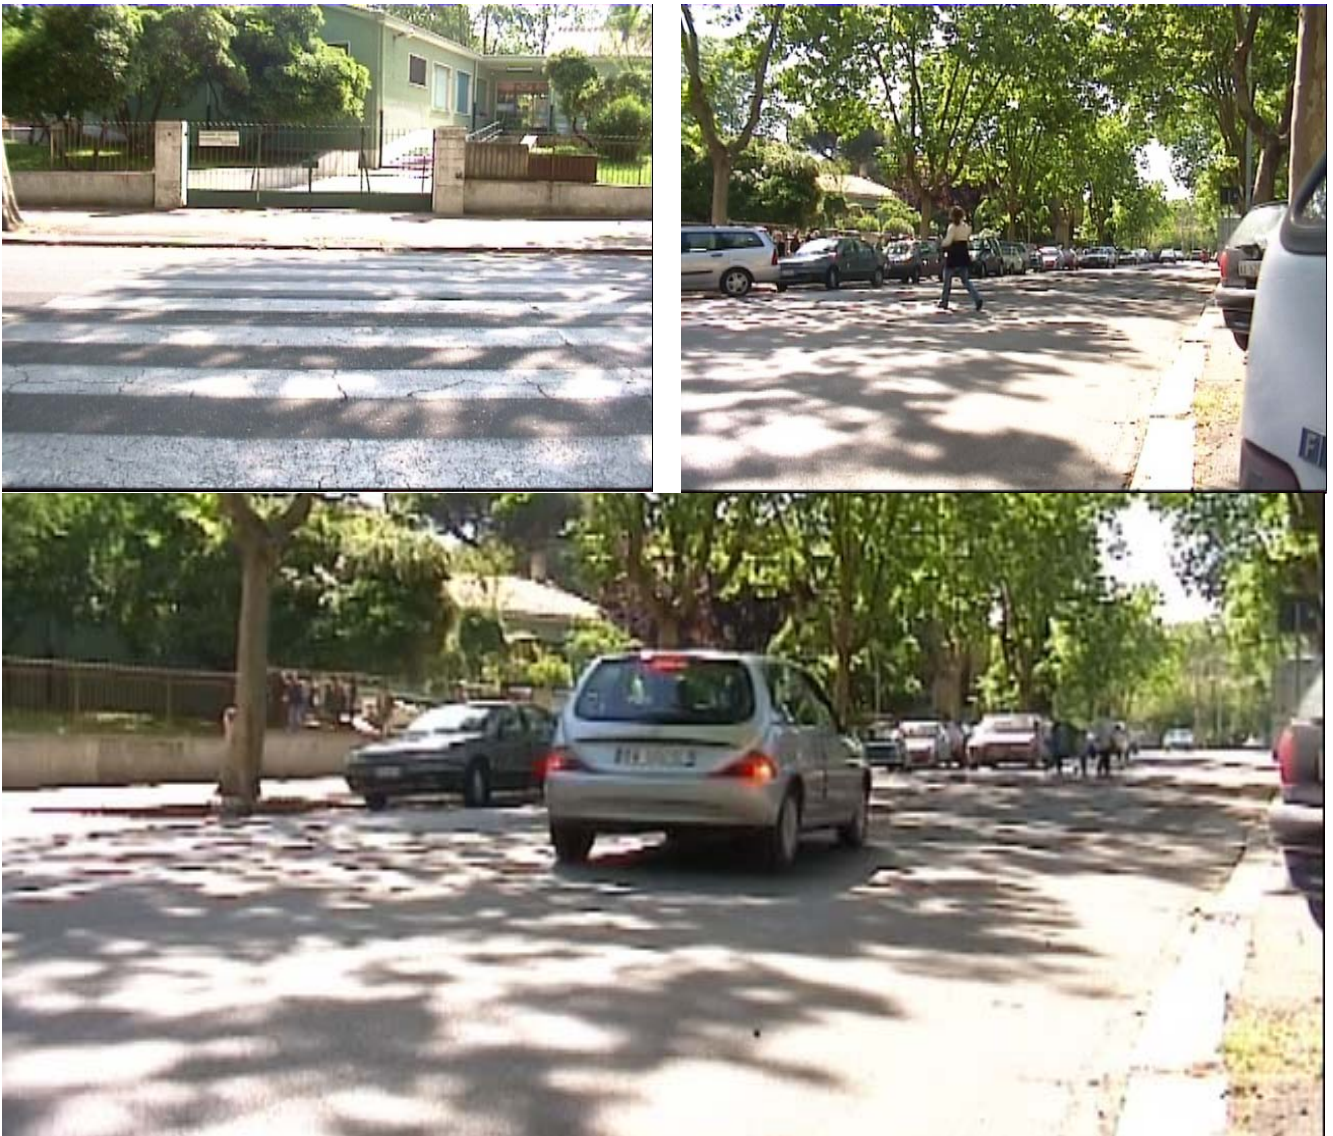
Figure 3: The crossing point (station 1) before the renewal

In order to have a more organic view of the spot measures have been made in three different points (see picture), results show that differences are small. Transversal section was constant along the considered stretch of road and showed two lanes (one for direction) 3.50m width each, parking along the street on both sides (2.00m on each side) and two 4.50m sidewalks. Speed limit, before the intervention, was fixed in 30 km/h. The pedestrians crossing, located in front of the school, was marked with simple zebra stripes, without any other enforcing measure.

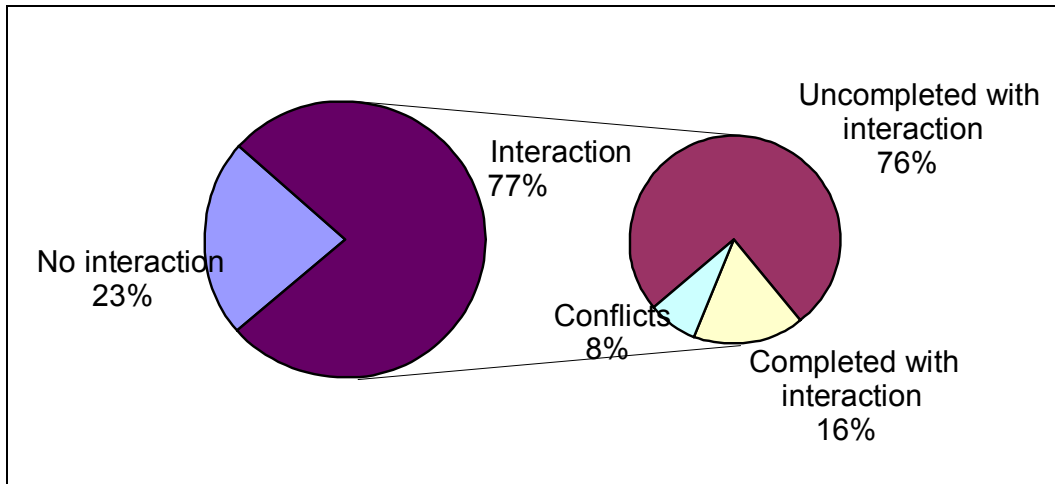
Figure 4: Functional quality of the crossing point chart

Quantitative observations of crossing pedestrians have been done at the crossing point in front of the school results, as reported in table 2, show that rather small, but not irrelevant, amount of conflicts, this is a consequence of the visibility condition that are rather good; on the other side the percentage of uncompleted crossing manoeuvre is very high, pedestrians decide not to take their right of way in nearly 60% of total crossing attempts.

In order to make data easier to be read the no interaction situation (which doesn't depend on the infrastructure characteristics, rather on the distribution of gaps) can be taken away (table 3), resulting percentages show even clearer the poor performance level of the existing crossing facility. Reasons seem to be the number (2) and width (3.50m) of the lanes in connection with rather high speeds.

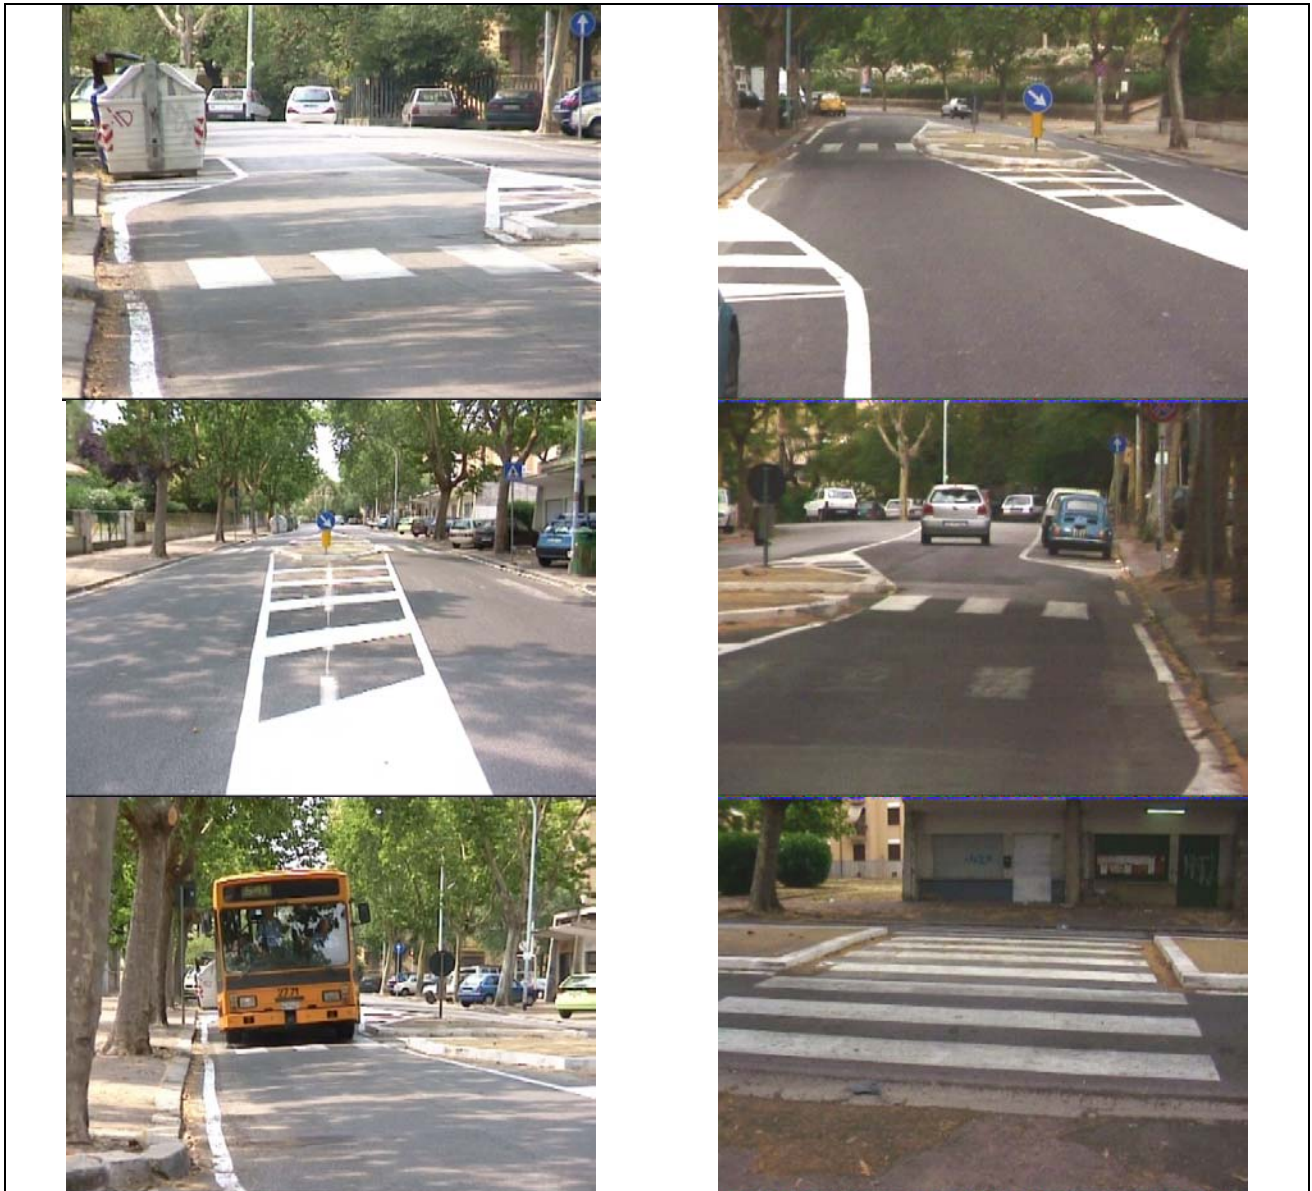
Figure 7: Views of the new crossing point

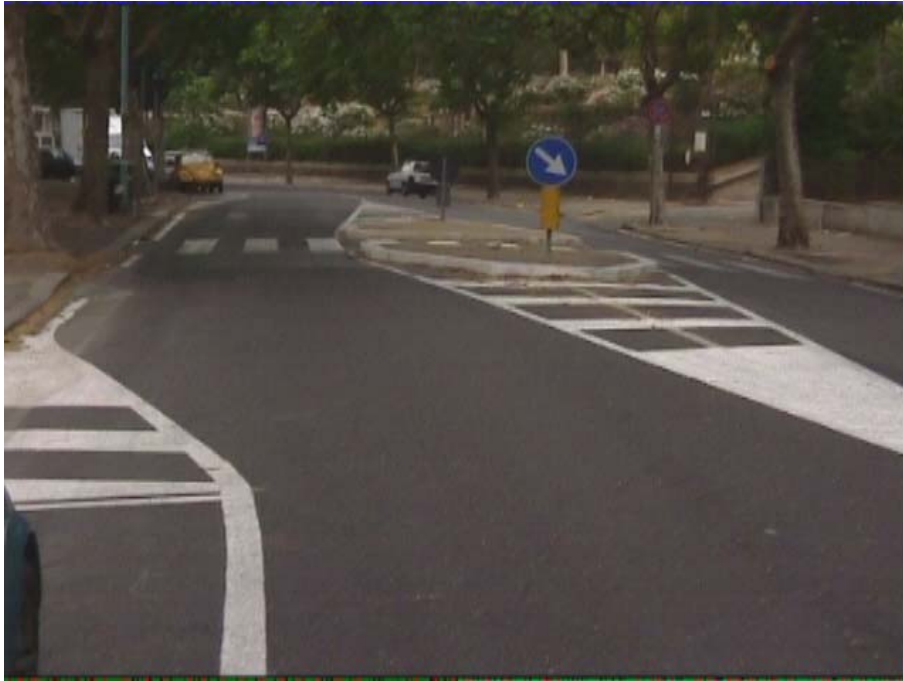
Figure 8: View of the new crossing point

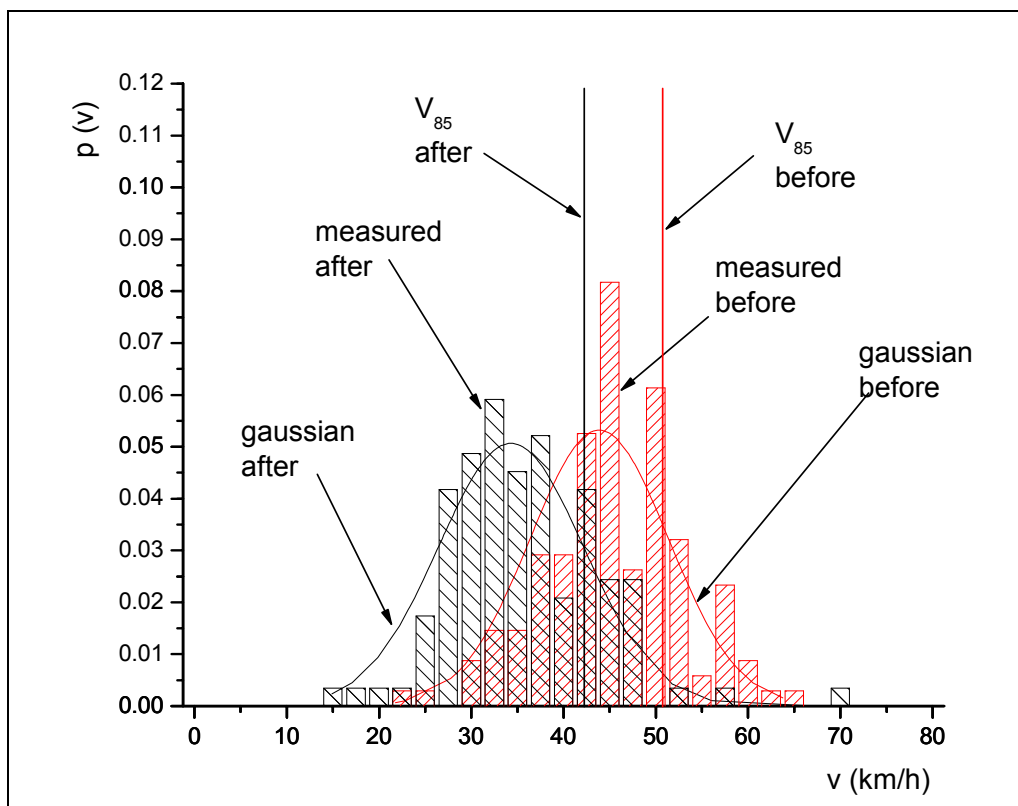
Figure 9: Speed comparison direction 1

In figures 9 and 10 speed distributions before and after the intervention are graphically shown, another view of the same data is reported in picture 11 and 12 (cumulate graphs), all representation clearly show that the standard deviation doesn't change (the width of the bell and the steepness of the cumulated chart remain the same before and after), but the overall speed decreases.

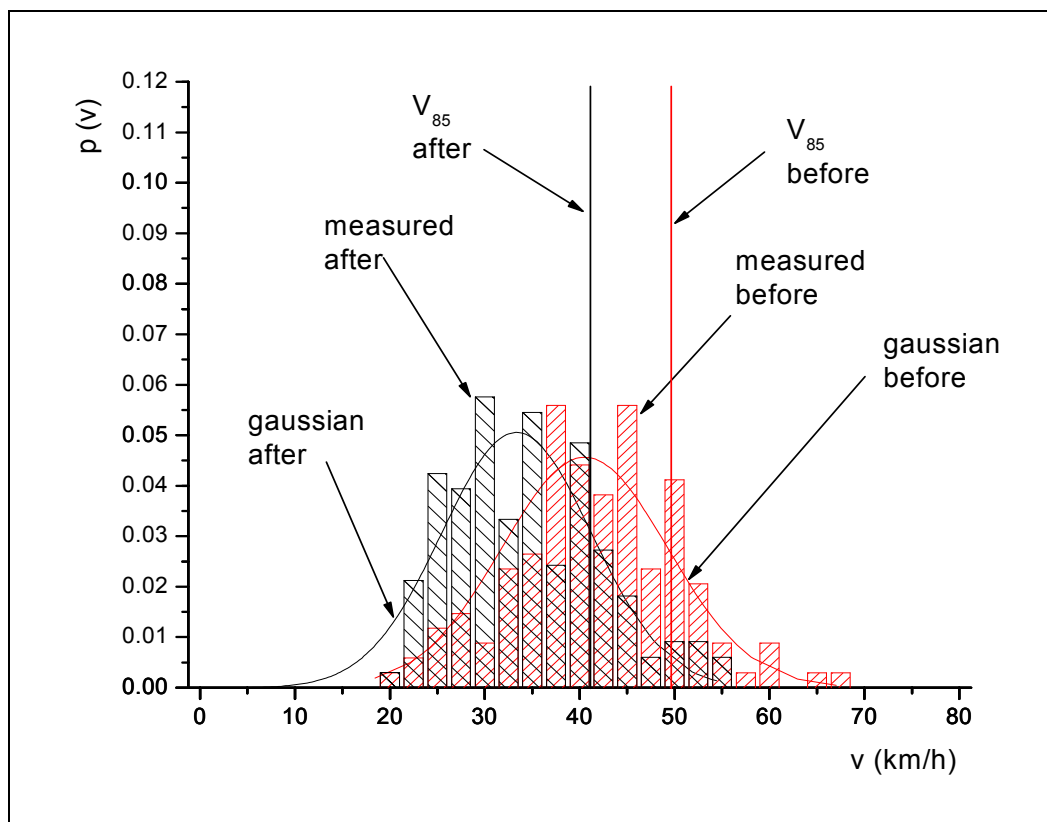
Figure 10: Speed comparison direction 2

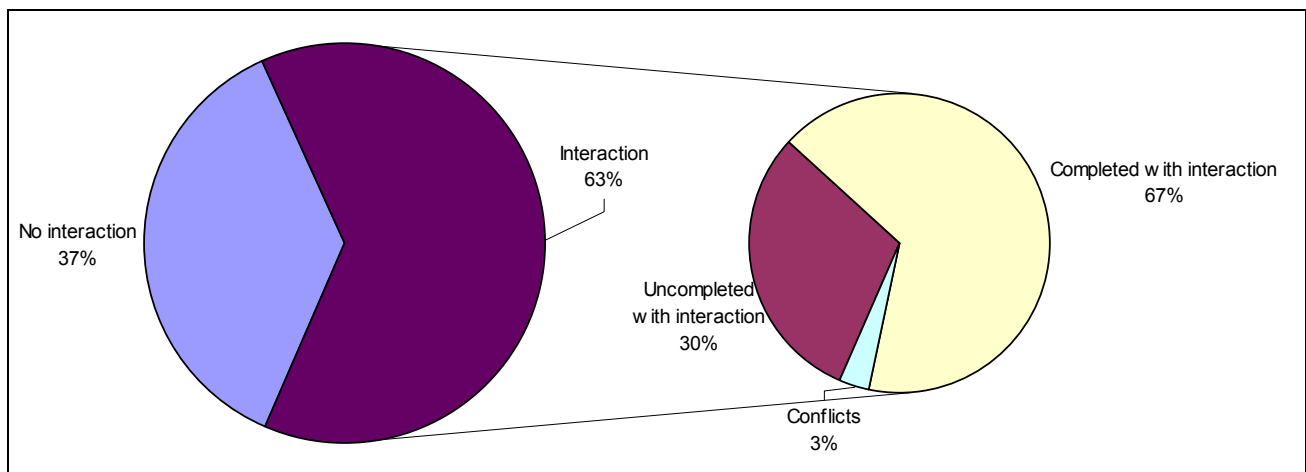
Figure 12: Functional quality of the crossing point chart

The new facility has a very strong effect on the functional quality of the crossing point, reasons are mainly the lower vehicular speeds and the division of the crossing distance in two parts, both factors allow pedestrians a better priority negotiation with car drivers that more often give way. Data are reported for the two crossing steps as well as aggregated, comparison with the situation before have been made only considering the aggregated data and not considering the “no interaction” case. Step 1 refers to the first part of the crossing manoeuvre (from the sidewalk to the median island), step 2 refers to the second part (from the island to the final sidewalk) regardless of the direction. The chi square test for a 2 degree of freedom problem (excluding the no interaction case) have been used to verify the significance of the shown percentage differences, and resulted in a value of 24.16 that warrants a good relationship between the variables. It is interesting that the conflicts recorded are all referred to the second part of the manoeuvre, probably because pedestrians waiting on the median platform, seeing the final goal so close, are more inclined to risk to take their right of way (but the figures are rather small).

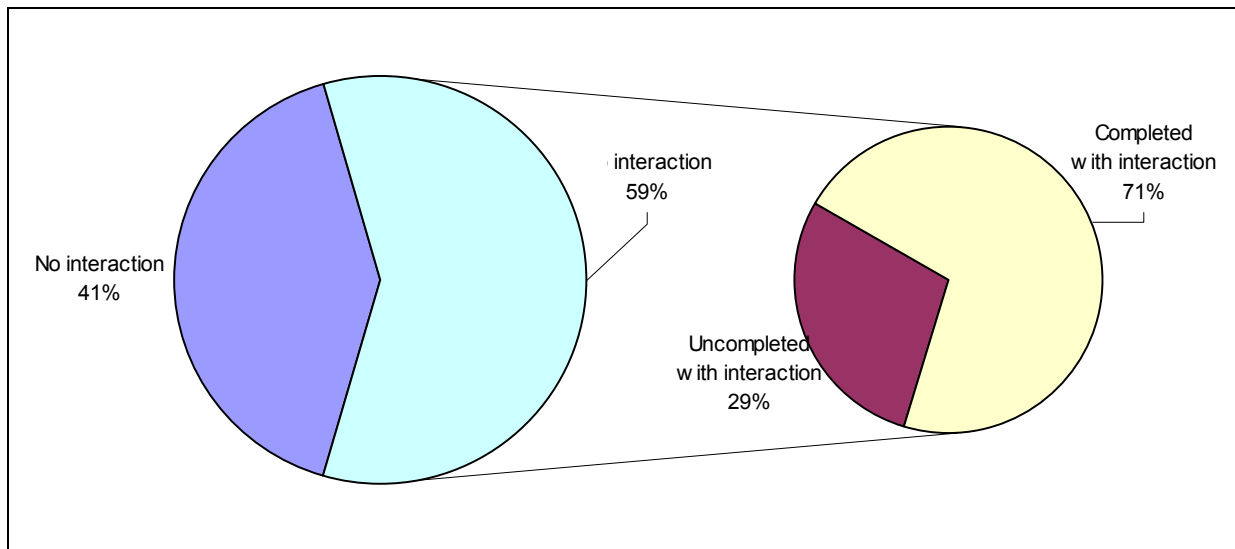
Figure 13: Functional quality of the crossing point chart

As one of the main complain to traffic calming devices is the stability of their performance against time, functional quality of the crossing point has been checked again one year after the construction to see if good performances fade away, after a short period, once drivers get accustomed with the new street design. Results are once again good, and show that non big differences exist with data recorded just after the construction and performance are somehow even better. The chi square value of 1.23 for a 2 degree of freedom problem (excluding the no interaction case) underlines that in this case no strong relationship exist and the small differences that exist are likely dependant on chance. This results make the speed measurement after one year redundant, since no performance level difference has to be explained.
