## MnDOT Road Doctor Program: Implementing Advanced Innovative Materials, Testing Procedures, and Pavement Evaluation Technologies – Minnesota Experience

MnDOT Office of Materials and Road Research (OMRR)

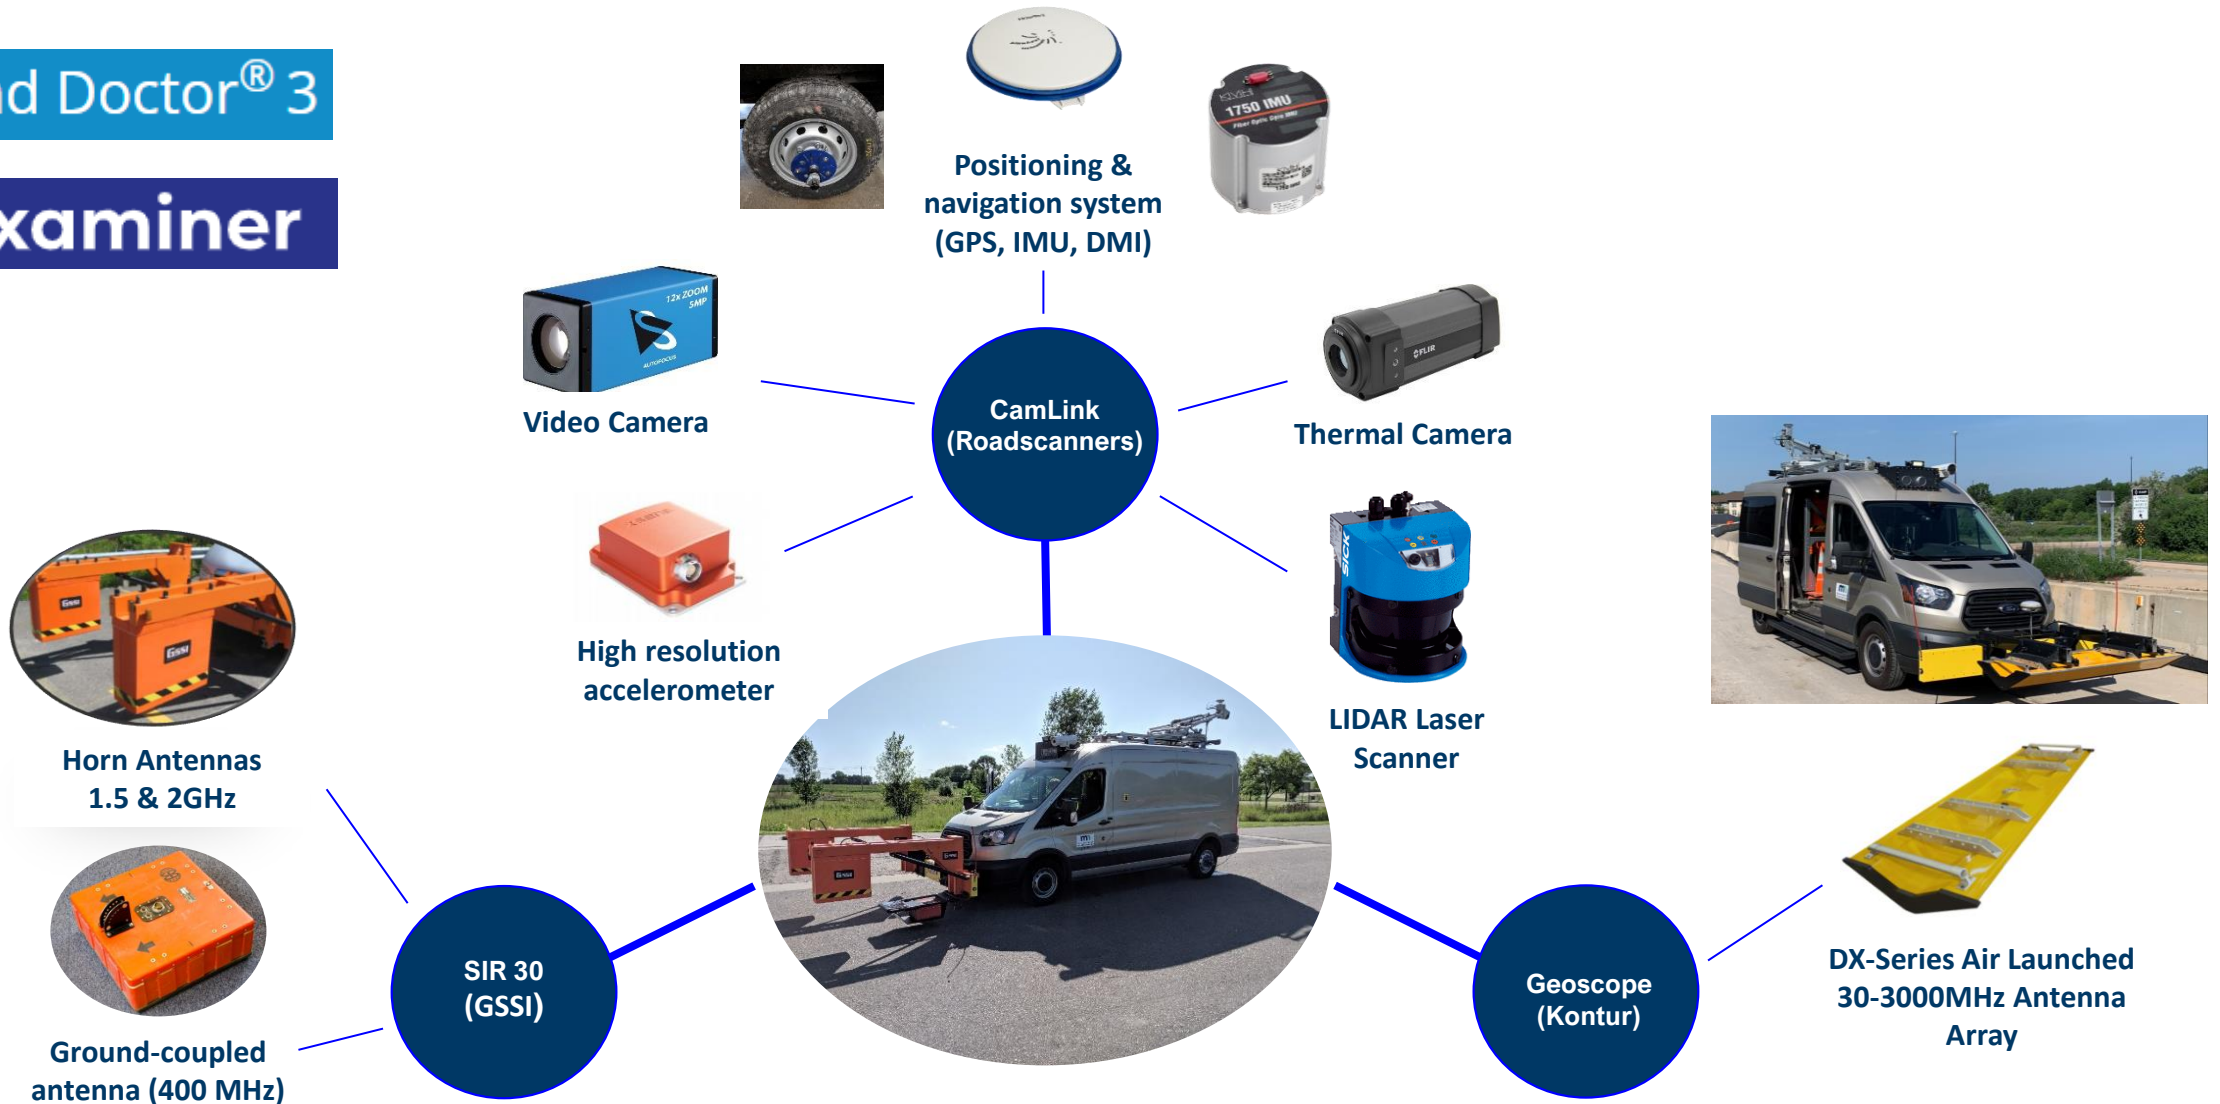
# MnDOT RDSV Data Collection, Fusion & Linking

Road Doctor® 3

Examiner

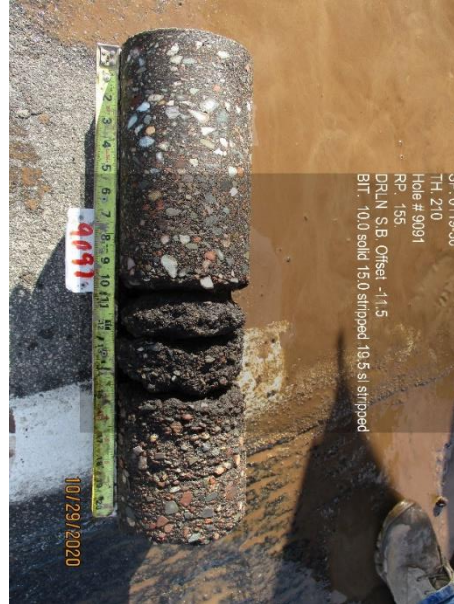
Stripping at the bottom layer of Full Depth AC pavement

New Asphalt Mixture

Old stripped Asphalt Mixture

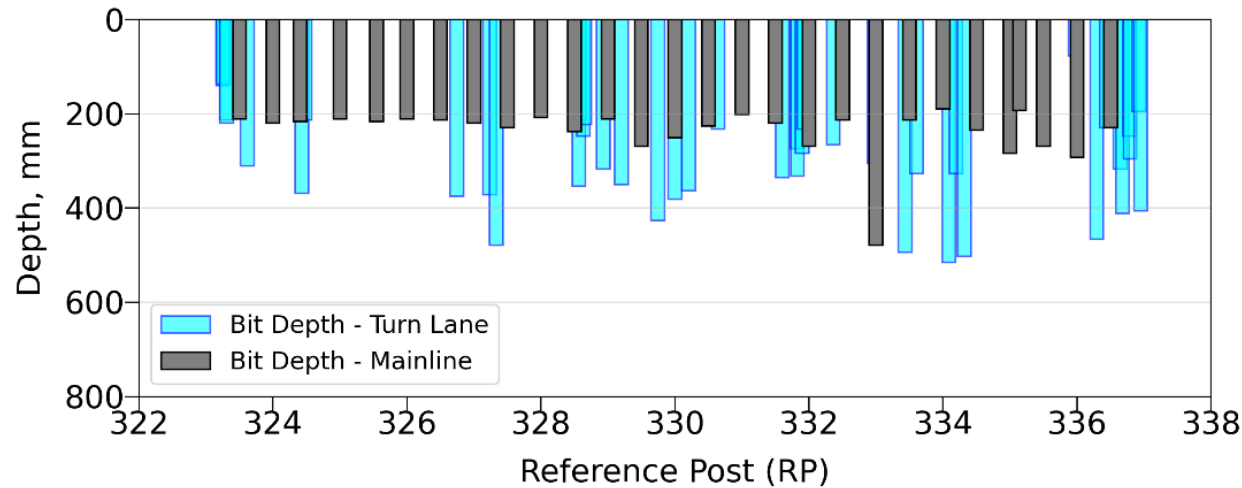
Depth of bituminous layer  
from coring data

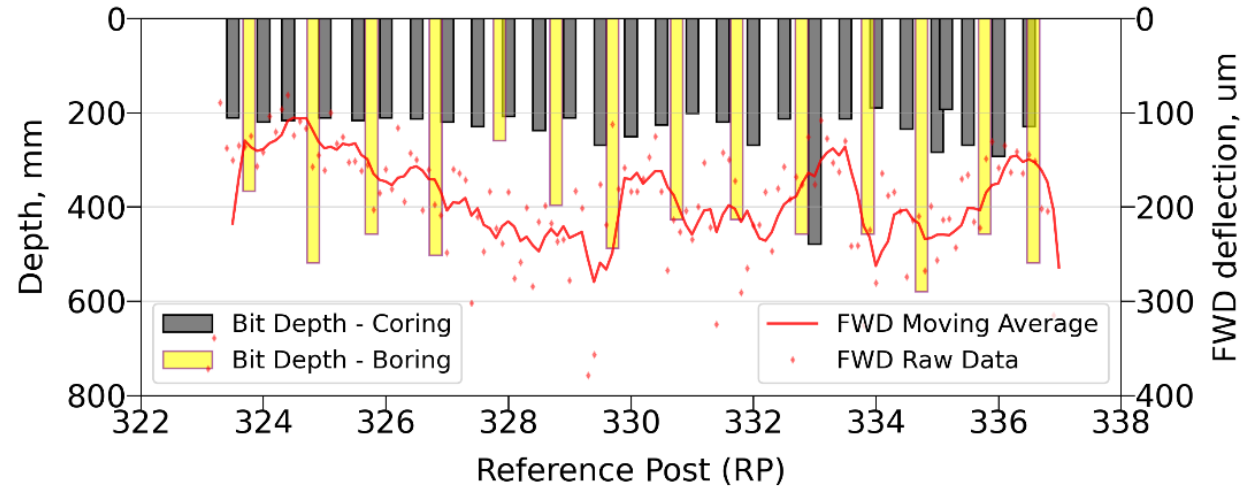
Depth of bituminous layer from  
coring and geo-probing data

Bottom layer with strong evidence of stripping  
deterioration

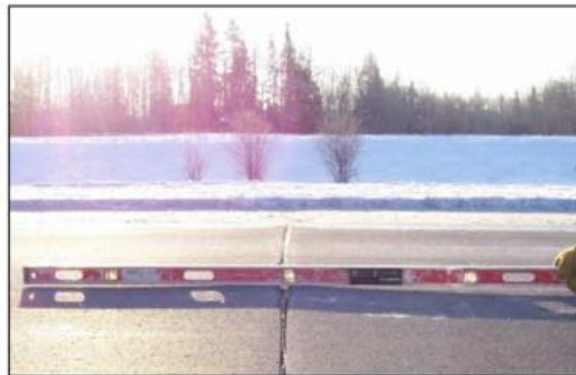
Manual measurement of a tented crack
