# TURKEY – ANATOLIAN MOTORWAY RETROFITTING OF VIADUCT 1

## ABSTRACT

This is to illustrate the design activities and works which turned out to be necessary for Viaduct 1, already built before the earthquake of 1999 which seriously damaged the area where it is located and caused so many deaths among the population.

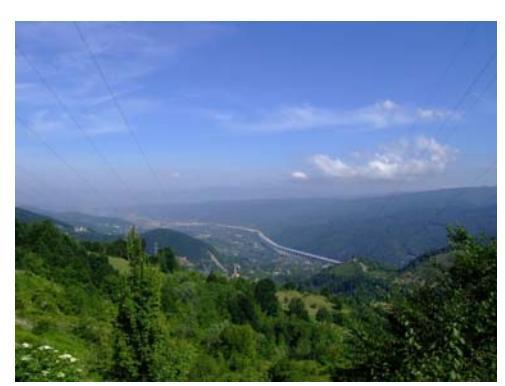
Figure 1 - Viaduct 1

This viaduct, approximately 2,400 m long, had just been completed as part of stretch 2 of the Anatolian Motorway Gümüşova-Gerede, between Istanbul and Ankara, and the structure was caused to undergo a non-scheduled full scale test, since it was located within the area where the earthquake proved to be more severe. In fact, at two thirds of the viaduct, the seismic event had caused a lateral fault slip toward NE-SW. The viaduct had been designed assuming, as seismic datum, an effective ground acceleration (EGA) amounting to 0.4 g, in agreement with AASHTO recommendations in force at that time (edition 1989), such parameters relating to an earthquake with a return period of 500 years.

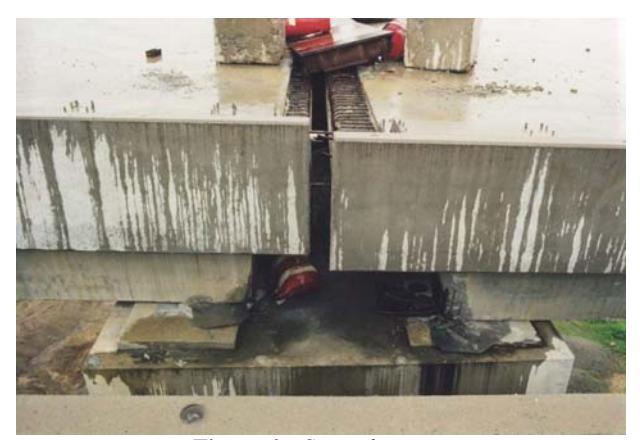
Figure 4 – Some damages

After a first overexcitement reaction, it was verified that the viaduct, even though seriously damaged, was still standing despite some piers, because of the fault slip, the ground had been displaced from original position by 100-120 cm and some spans were hanging in space out of the bearing surface on the pier cap, supported exclusively by the reinforcing rods and by the concrete of the slab joining the deck sections.

Fortunately, the damage suffered by only some of the piles was insignificant and some new piles were driven around the edge of some foundations plinths, and the reinforcement bars of the foundation plinths themselves were re-connected with the concrete structure by new casting and by enlarging the base, while none of the piers suffered any crack or damage; only at the position where the viaduct crosses the fault, a 3° tilting of some piers was found and redressed by lifting the deck, thus proving that all structural deflections were within the elastic field.

The solution devised by the designers and approved by Client "simply" changed the deck-bearings system: the simple deck-on-bearings scheme was changed into a continuous deck on "seismic bearings" (two per each pier cap) allowing for movements up to +/- 900 mm in the area where the viaduct crosses the fault.

The longitudinal continuity of existing deck sections was achieved by using a rigid transverse post-compressed diaphragm, cast in-situ and embedding the ends of the beams constituting the two adjacent deck sections.

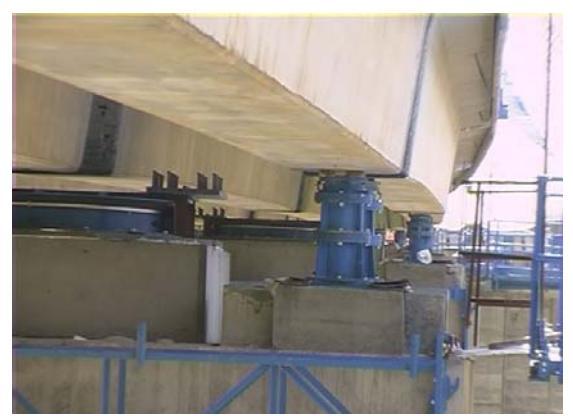
Figure 5 – Retrofitting work

The changes involved the re-positioning of the deck, both transversally and longitudinally, at a position 80 cm higher than the original design, in order to allow the installation of new spherical bearings manufactured by E.P.S. (Earthquake Protection Systems, Inc.) of Richmond – California, called "Friction Pendulum Isolation Bearings", anchored to the pier cap and embedded in the new purposely manufactured post-stressed beam, the so-called diaphragm beam, representing the cross-beam of the deck and enclosing the 7 pre-stressed reinforced concreted beams of the deck itself.

The most delicate and complex operation was lifting the ten continuous decks, the socalled "*segment*", already positioned at a maximum altitude of 50 m, displacing it so as to transversally and longitudinally reposition the same at the centre of the pier caps: it should be noted that the weight of each deck section between two pier caps including the seven beams and the slab is of approximately 1,400 tons. The hoisting equipment and the special hydraulic jacks were designed and manufactured by Freyssinet itself, which took care of fine-tuning also the synchronized system for the simultaneous and co-ordinated displacement of the segment, that is to say the 10 deck sections.

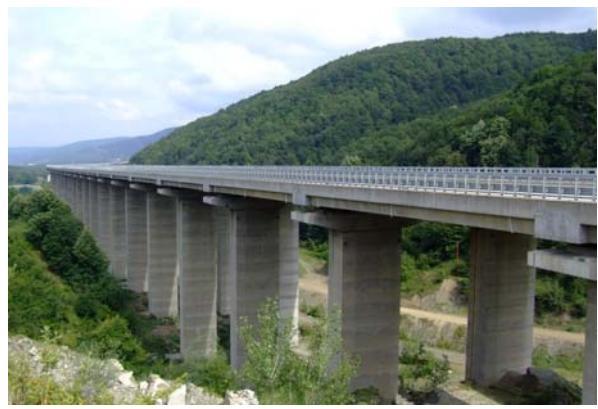
Figure 6 - Final work

Nowadays, the recovery has been successfully completed and Viaduct 1, fully restored, is ready to confront its new life and withstand the intense traffic which shall go through this crucial link between Istanbul and Ankara.
